Flightfax

ARMY AVIATION
RISK-MANAGEMENT
INFORMATION

MAY 1998 ♦ VOL 26 ♦ NO 8

Never stop flying the aircraft . . .

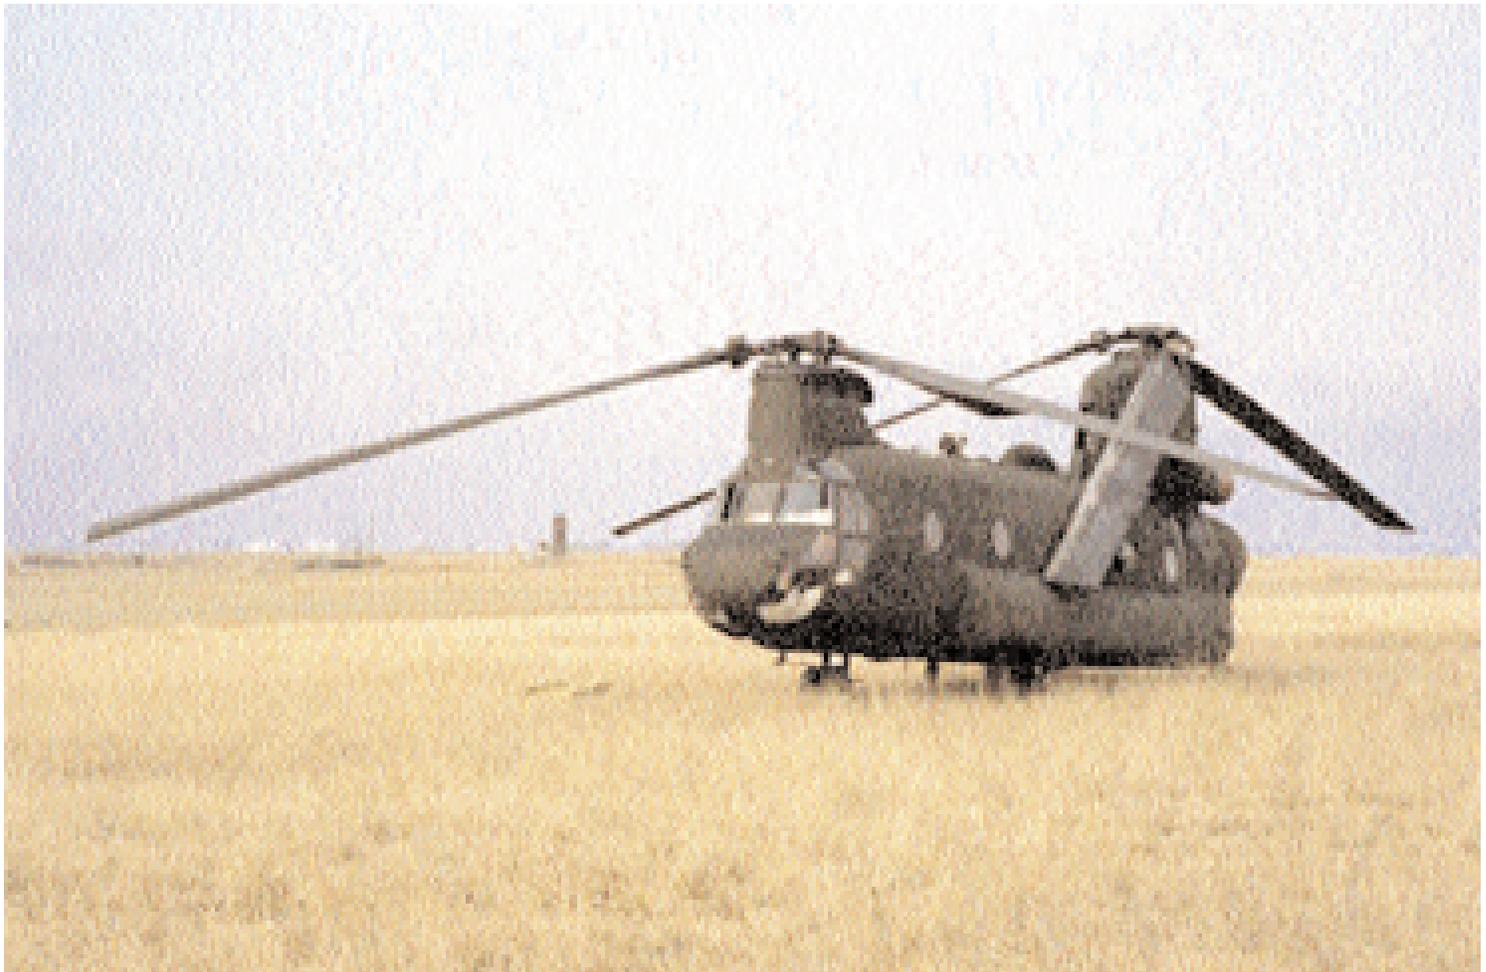
After 360-degree roll in flight, the crew managed to land the Chinook with surprisingly little damage. During shutdown, however, damaged droop stops allowed the aft rotor blades to pound into the fuselage.

The aircraft miraculously returned to a wheels-down attitude at about 250 feet agl. The pilots were able to control the aircraft to a near-normal touchdown, although full right pedal was still necessary to control aircraft heading. As the crew performed an emergency shutdown, the aft rotor

blades made contact with the fuselage since the damaged droop stops did not operate normally.

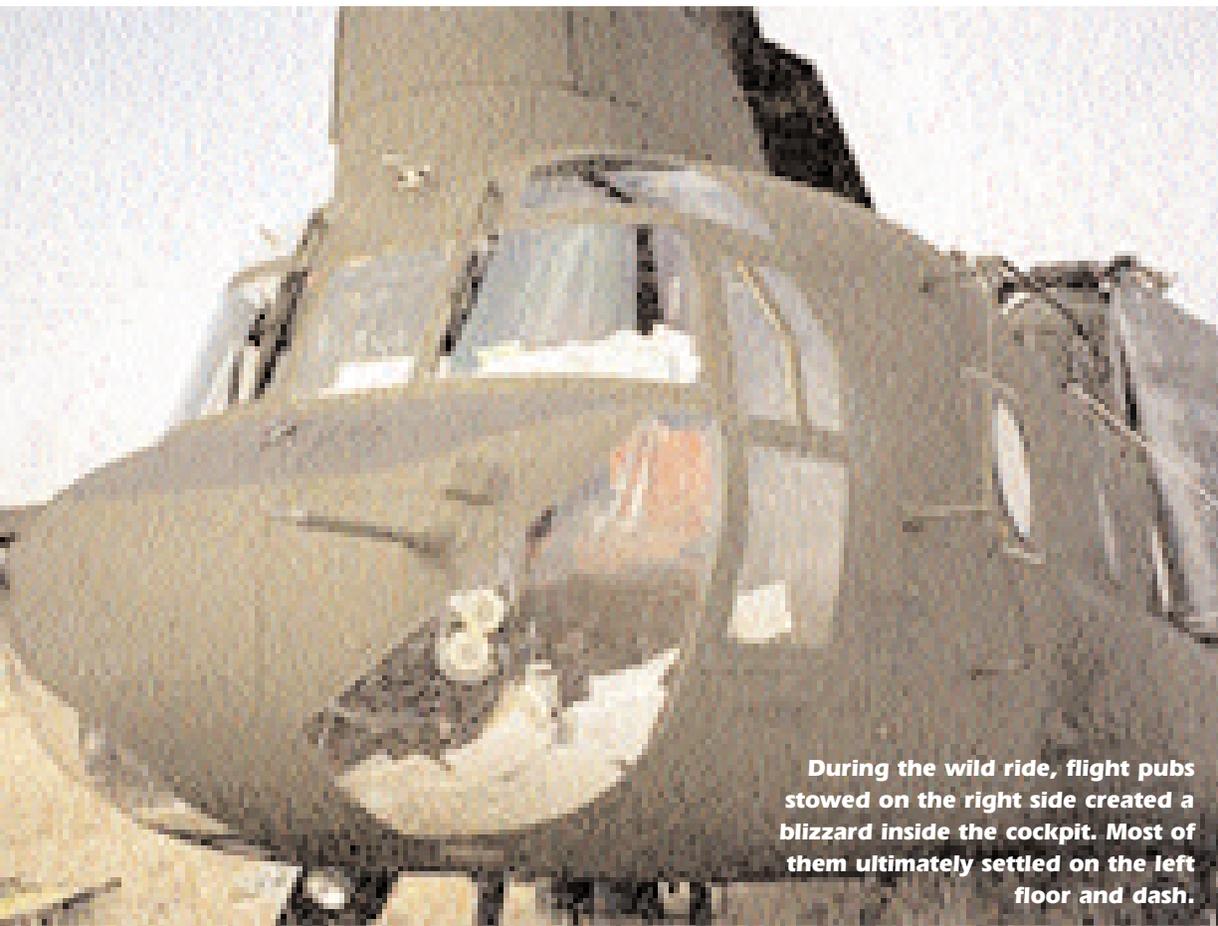
During the wild ride, flight pubs stowed on the right side created a blizzard inside the cockpit. Most of them ultimately settled on the left floor and dash.

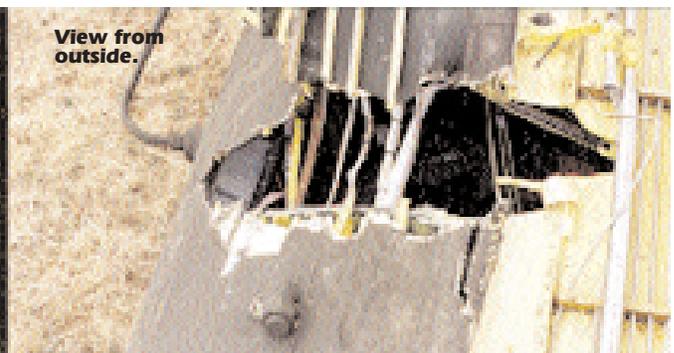
And that's when the rotor blades started slamming into the fuselage.

Aft rotor blades tore hole in top of fuselage during emergency shutdown.
