ARMY AIRCRAFT SAFETY PERFORMANCE REVIEW

December 1992

Army Aircraft Safety Performance

FY
87

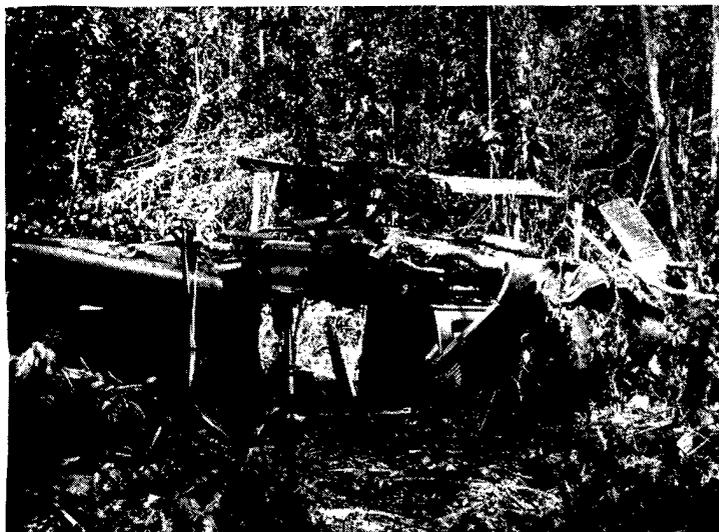
The aircraft was taking off from a confined area. As the pilot added power, the number 1 power turbine wheel in the number 1 engine failed. Due to low airspeed and high gross weight, number 2 engine power available was insufficient to maintain flight. The aircraft settled into the trees.

Cause: The engine failed due to debonding and loss of portions of the shroud segment honeycomb and filler material in the turbine case. This created an uneven surface on the stator honeycomb, which disrupted airflow around the gas generator rotor blade tips. This created a resonance frequency and stress, which caused cracking in the blade root and subsequent fracturing of the blades. Contributing to the severity of the injuries was the fact that troop seats and restraint systems had been removed from the aircraft.

Cause: Failure of number 1 turbine at an altitude, airspeed, and gross weight where single-engine power was insufficient to maintain flight.

Recommended actions: *Higher level:* Inform all assigned of this accident and provide restraint systems and seats for all occupants. *Army level:* Accelerate the application of MWO 55-2840-248-5032 for all T700-GE-700 engines, which will add a damper to the turbine blades. Develop an engine-vibration inspection to identify engines with excessive resonance-frequency vibrations.

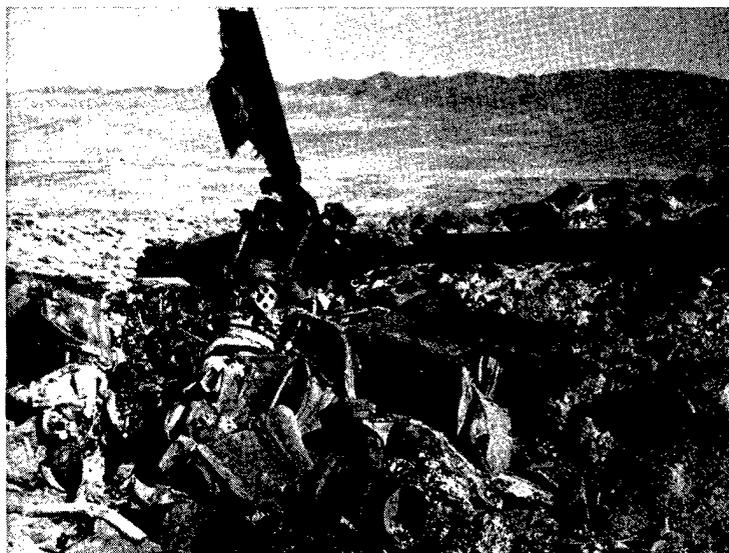
Result: Four fatalities, a destroyed aircraft, and a cost of \$8,048,397.

Cause: The crew failed to maintain terrain clearance. The most probable reason for this failure is that either the crew was overconfident in their ability to fly low and fast without striking obstacles, or the crew's attention was drawn to something inside the cockpit. Because of the high airspeed at low altitude, the crew had less reaction time to avoid obstacles.

Cause: Failure to maintain terrain clearance while flying low and fast.

Recommended actions: Discuss tactical flight procedures for desert and mountainous terrain, as written in TC 1-201, with emphasis on terrain flight techniques, aircrew responsibilities, navigation, and aircraft performance and handling.

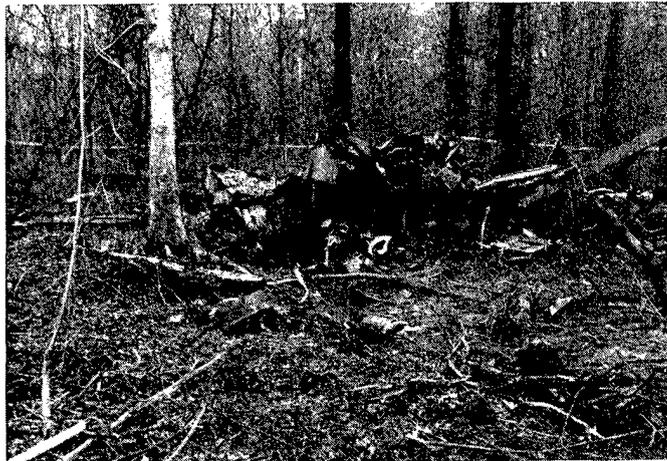
Cause: The lead UH-60 was flight following with unit operations, while the single UH-60 was flight following with the post facility. There was no require-

ment for the aircrews to make position reports on a common frequency, which would have alerted both accident UH-60s of their merging course. Contributing to this accident were the visual limitations associated with NVGs and the restricted field of view of UH-60 front and side windows.

Cause: Aircrews failed to see and avoid each other due to equipment design and flight-following procedures.

Recommended actions: *Higher level:* Establish flight-following procedures on a common frequency that requires position reporting. *Army level:* Improve the field of view of UH-60 pilot/copilot windscreen, side windows, and gunner's door windows.

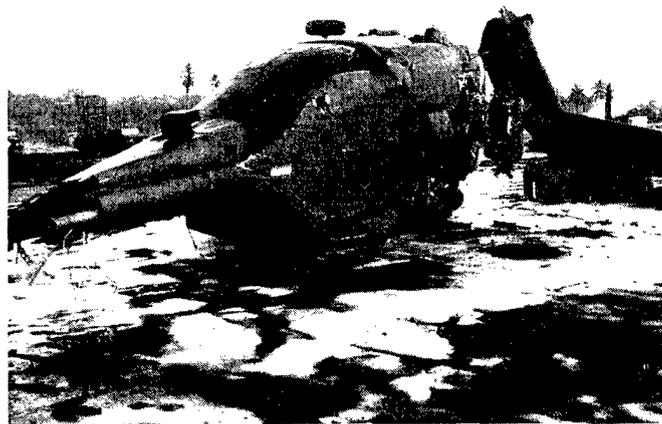
Cause: The crews of the two aircraft failed to see each other in time to avoid the collision. The IP of aircraft #1 was not adequately trained to perform the duties of NVG IP. As a result, he became task saturated and forgot to call out of parking and taking the runway. His lack of radio calls precluded the crew of the UH-60 hovering down the runway from knowing that there was any traffic on the runway.

Cause: Pilot failed to alert other aircraft of his intentions.

Recommended actions: Ensure that NVG IPs receive proper unit training in accordance with FM 1-219 and that crew chiefs/observers are adequately trained in clearing their aircraft of hazards.

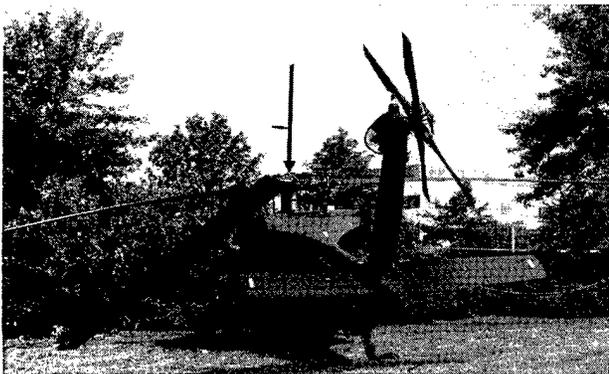
Cause: IP chose the wrong course of action for a stabilator malfunction (automatic mode failure). Instead of making a go-around or bringing the aircraft to a hover, he attempted a forced landing with insufficient forward clearance from trees. His judgment was affected by several factors: distraction,

Cause: Pilot chose wrong course of action for a stabilator malfunction.

lack of confidence in aircraft performance, and lack of knowledge of stabilator manual mode operations.

Recommended actions: Provide additional instruction to the IP on the capabilities of the UH-60 with the stabilator in a fixed position.

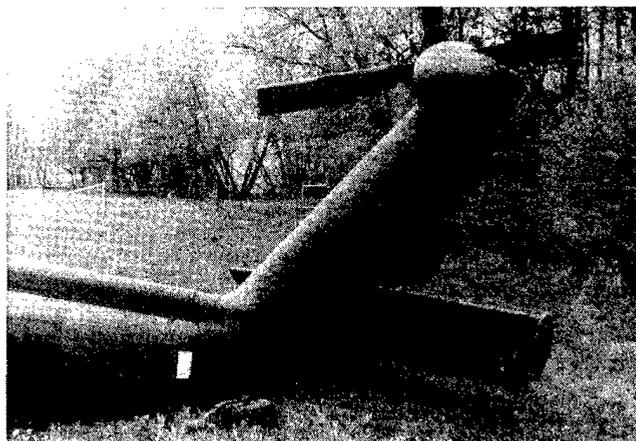
Cause: The transmission blower shaft retaining nut was improperly torqued by the manufacturer. This allowed the shaft to develop play, which eventually caused the flange splines to fail.

Cause: Failure of the transmission blower shaft splines.

Recommended actions: Army level: Issue AVUM units a flex boroscope so that a complete inspection of the drive shaft can be made.

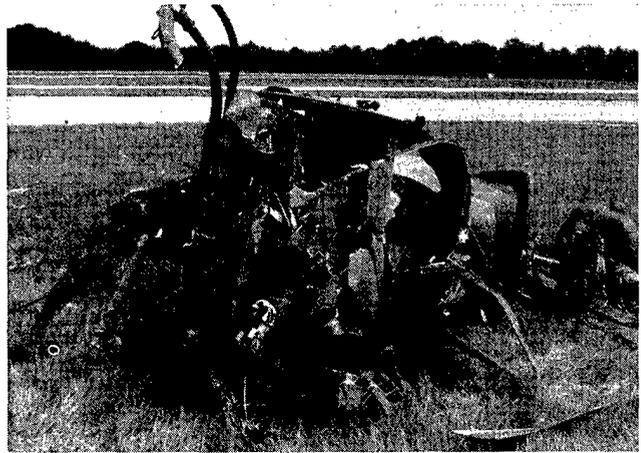
On an NVG training mission while at a forward hover on a stagefield, the IP misinterpreted aircraft attitude. He sensed the aircraft in a pitch-up, right-roll attitude and responded with rapid left forward cyclic and increased collective. This caused the main rotor to tilt down approximately 39 degrees to the left front quadrant (10 to 11 o'clock position) and strike the taxiway. The aircraft then began a rapid right spin, crashing out of control and coming to rest on its left side. The aircraft was damaged beyond economical repair. The rated student pilot's injury required only first aid; the IP received a minor knee injury that placed him in a limited-duty status for 7 days.

Cause: The IP's actions resulted from a combination of factors that culminated in spatial disorientation. He was self-medicating an aggravated vestibular condition that made him susceptible to spatial disorientation. Although current, the IP was only marginally proficient with NVGs. He had flown with NVGs only 4.9 hours in the previous 4 months.

Cause: Spatial disorientation.

Recommended actions: Unit level: Brief the accident and ensure all personnel are aware of the self-medication restriction in AR 40-8, with specific emphasis on the requirement to notify a flight surgeon before using over-the-counter drugs.

Army level: Initiate a study of Army aviators with increased risk for spatial disorientation and the associated flight risks that result from an aggravated vestibular condition.

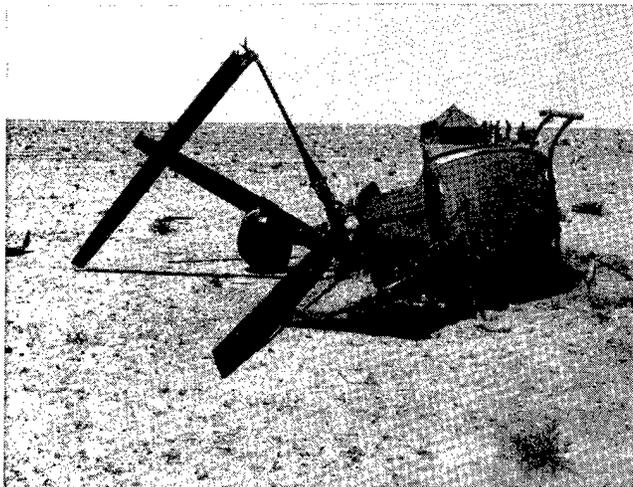
Cause: Engine failure followed by emergency landing in soft sand.

Recommended actions: Unit level: Emphasize that pilots should anticipate soft terrain when landing to unimproved areas. **Army level:** Consider changing the material of the impeller and plain seal of the fuel boost pump. Consider incorporating into the OH-58D transition program provisions for giving pilots some level of experience in minimum ground run landing. Evaluate current emergency procedures for in-flight failures of the fuel boost pump; consider whether "land as soon as practical" should be changed to "land as soon as possible." Consider relocating the lower nose-mounted wire cutter to allow more ground clearance.

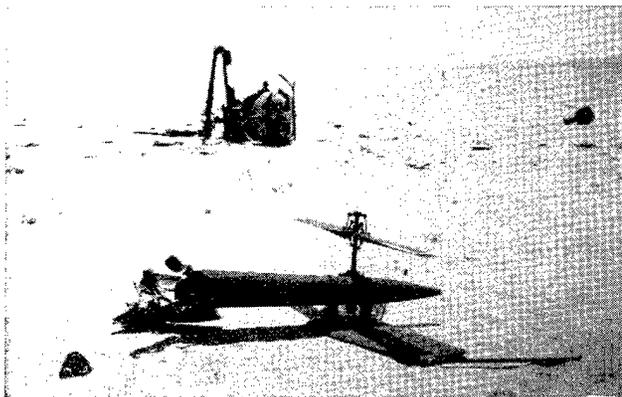
Cause: The crew failed to recognize rising desert terrain in their flight path due to (1) inadequate unit training in flying under night, aided, totally blacked out conditions; (2) haste to catch up with their sister element, resulting in their overflying the capability of their NVGs to provide adequate terrain definition under the totally blacked out desert conditions; (3) substandard NVGs, which placed the crew at a disadvantage in an already difficult situation; and (4) lack of a radar altimeter audio signal that would have warned the crew they were approaching critical proximity to the ground.

Cause: Failure to recognize rising terrain.

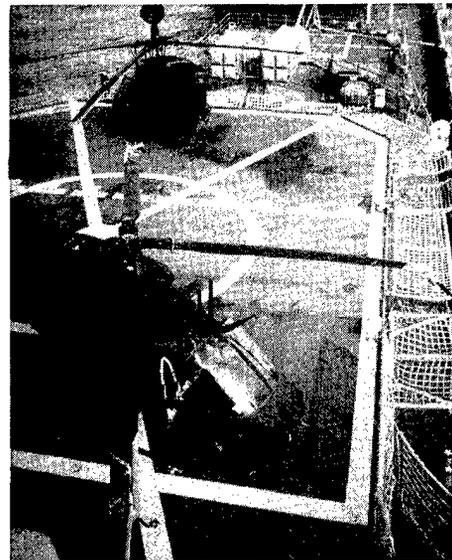
Cause: Overconfidence and inadequate procedures.

Recommended actions: *Unit level:* Inform all personnel of the circumstances of this accident, with emphasis on how overconfidence contributed. *Higher level:* Establish procedures for making decisions to allow simultaneous dual-aircraft operations from ships whose flight decks have been designated as single-spot decks.

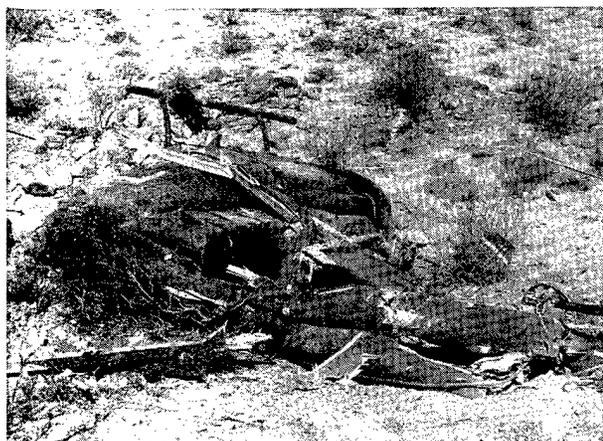
During night tactical training with ANVIS-6 NVGs in use, the low-fuel caution light illuminated. The aircraft was flown another 6 minutes and landed at a lager site, where it was shut down about 10 minutes later. The aircraft was later started and departed the lager site with the low-fuel caution light illuminated and 52 to 58 pounds of fuel on board. About 1

Cause: Failure to follow procedures.

minute into the flight, during a slow right turn at 50 knots and 100 to 200 feet agl, the engine quit. The aircraft was autorotated and landed in a rocky area. The left skid settled atop a large rock, and the aircraft rolled to the right, destroying the rotor system and causing major damage to the aircraft. There were no injuries.

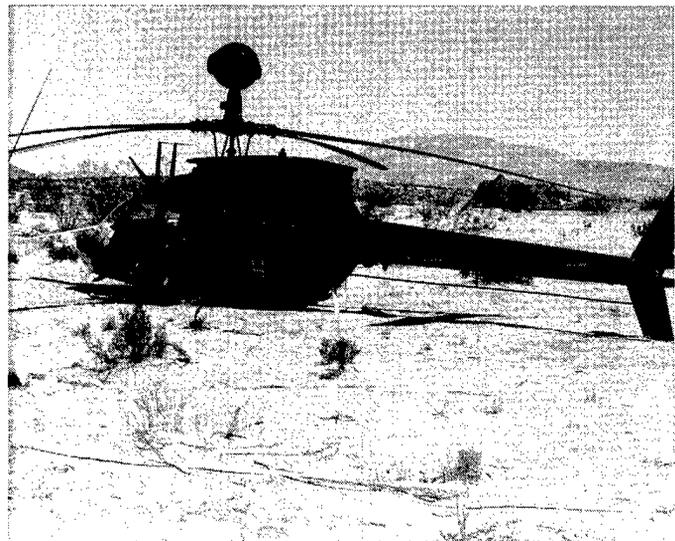
Cause: Loose "B" nut that connects fuel hose to fuel boost pump.

Recommended action: Army level: Issue a safety-of-flight message to the field requiring a one-time inspection of all fuel system "B" nuts attaching fuel hoses to the fuel boost pumps in the OH-58D.

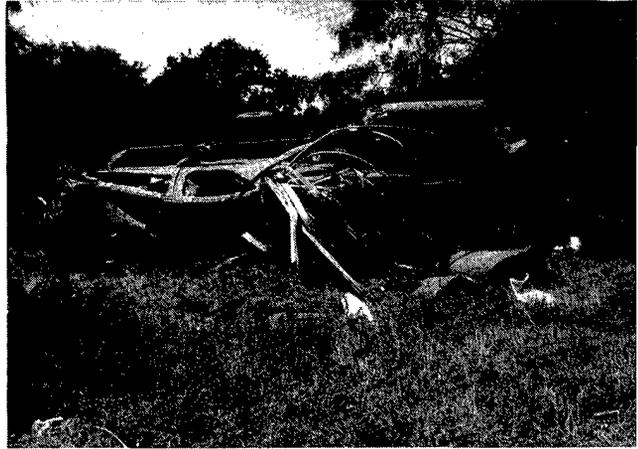
Cause: Loss of engine power and inadequate crew coordination.

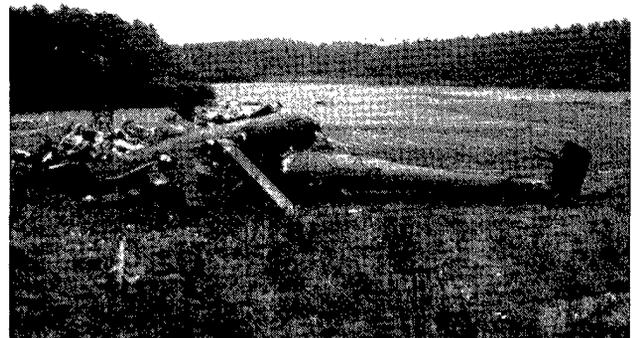
Cause: Crew failed to maintain clearance while crossing wires.

Recommended actions: Army level: Procure an obstacle-avoidance device for the AH-64 helicopter. This device should also be used in other tactical rotary-wing aircraft that commonly operate in terrain-flight mode.

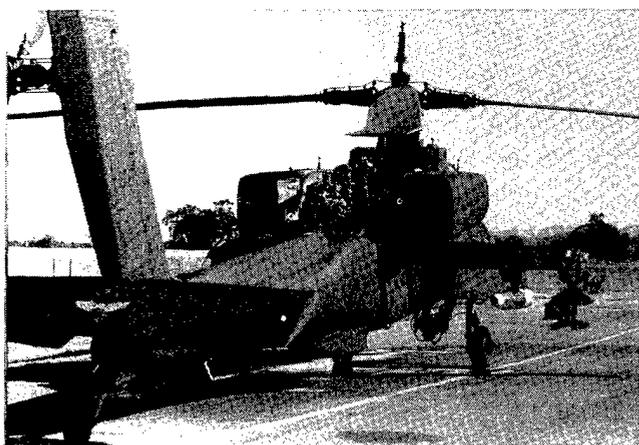
Cause: Failure of duplex bearing in forward end of power takeoff clutch due to lack of lubrication.

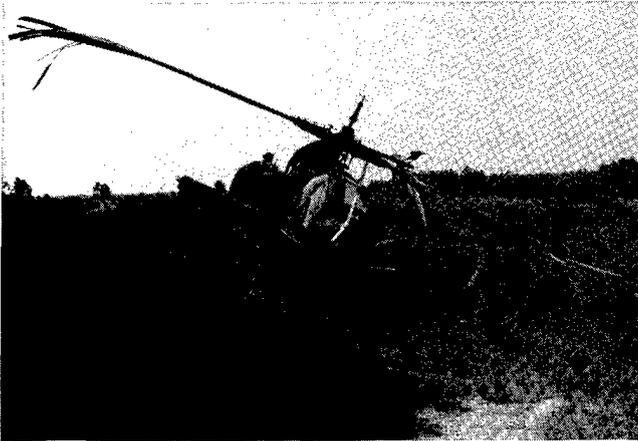
failure caused a loss of antitorque control. Without antitorque thrust, main rotor torque caused the aircraft to abruptly yaw right. Simultaneously, the aircraft descended, striking the ground on its left main gear. It slid laterally for 4 feet until it came to rest.

Cause: Crew failed to maintain a stabilized hover due to improper division of attention.

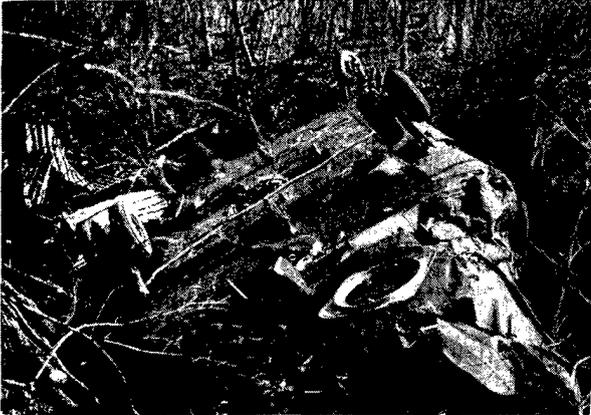
The CH-47D was on a day, low-level, VFR training mission with a slingload. While ascending a draw to cross a ridge, the aircraft entered a cloud layer and the crew lost visual ground reference. The crew initiated proper emergency procedures, but by the time contact was reestablished with the ridge, collision was unavoidable. The aircraft struck a 44-degree slope in a near-level attitude. Rotor blade contact with trees and the ground caused the aircraft to roll inverted and slide down the ridge about 120 feet.

Cause: Human error.

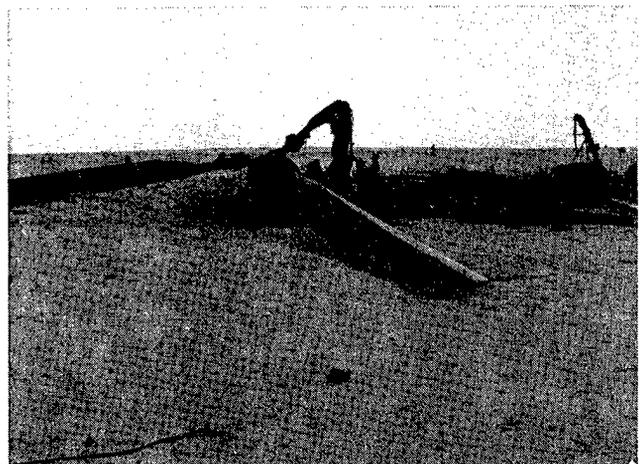
Cause: Failure of engine transmission pinion drive gear.

Recommended actions: Stress the importance of detailed crew and passenger briefings to ensure that, in the event of an emergency, all personnel understand their duties and all avenues of egress. Stress to all CH-47 crews the importance of providing all possible avenues of egress to passengers occupying vehicles on aircraft during tactical moves. Improve quality control in the manufacturing process of the identified defective gears used in CH-47D transmissions.

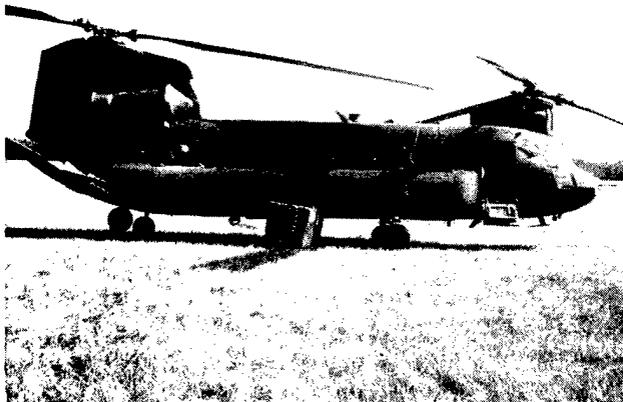
Cause: Failure to follow procedures.

Recommended actions: Emphasize how deviations from standards can result in crewmembers' attention being focused away from obstacle clearance.
