**Failure Analysis of a Cracked CH-47 Swashplate
Rotating Ring, S/N BCW-1379**

ARL-TR-3826

June 2006

Scott Grendahl
Weapons and Materials Research Directorate, ARL

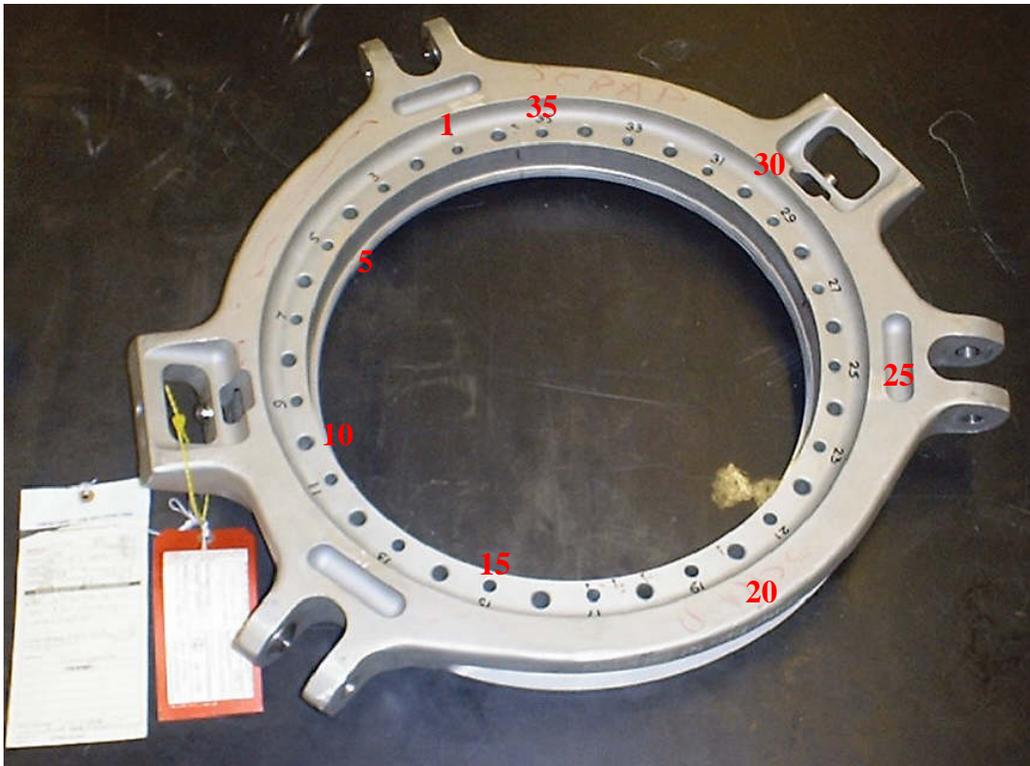
Figure 1. As-received component BCW-1379 swashplate rotating ring.

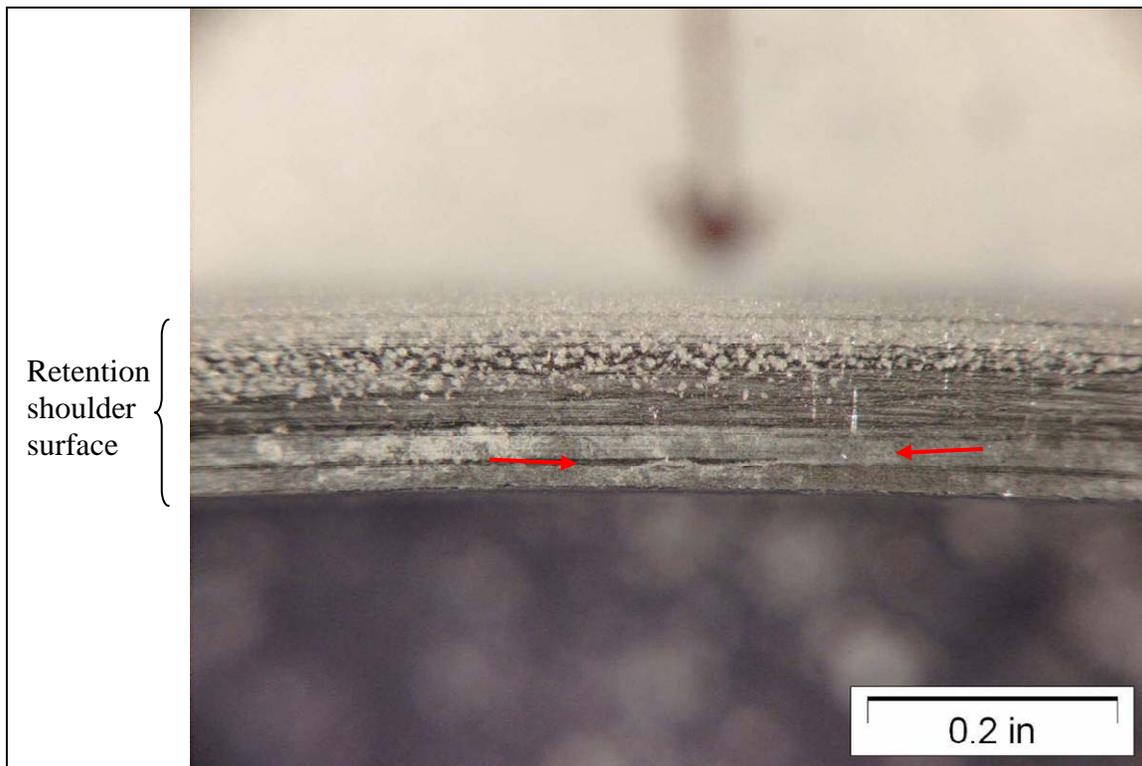
Figure 2. White light indication of the circumferential crack at hole 5.

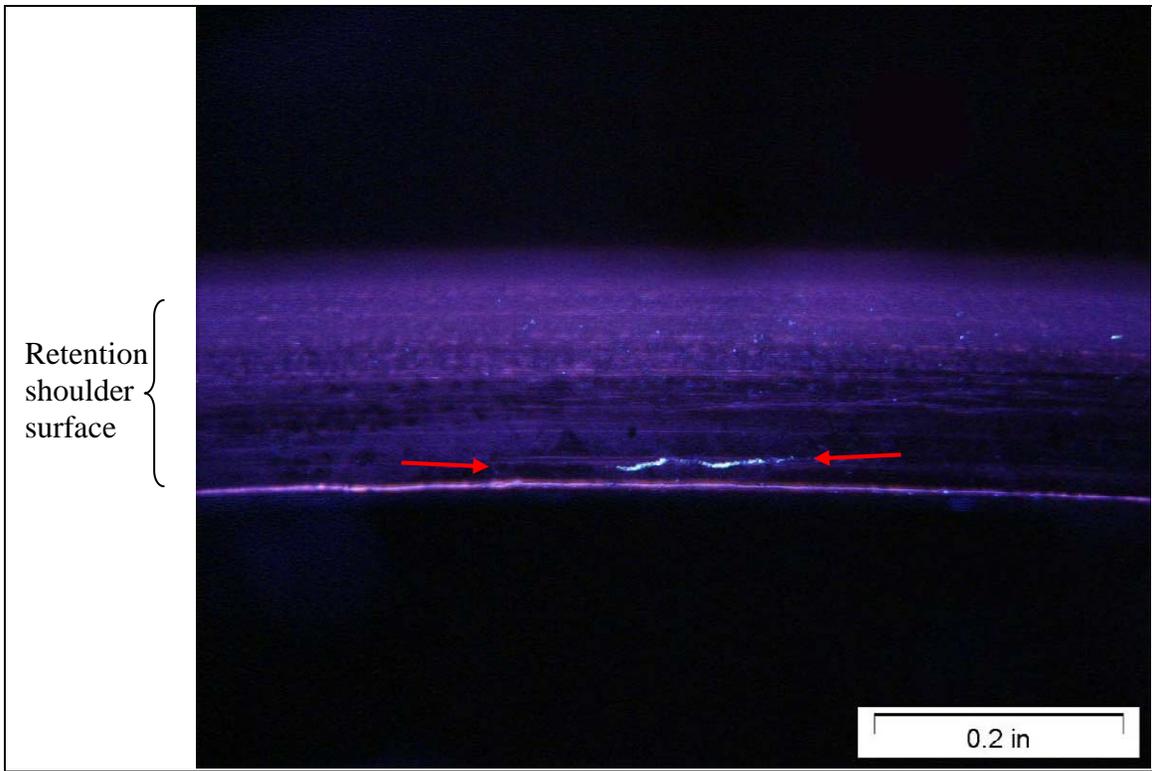
Figure 3. Black light indication of the circumferential crack at hole 5.

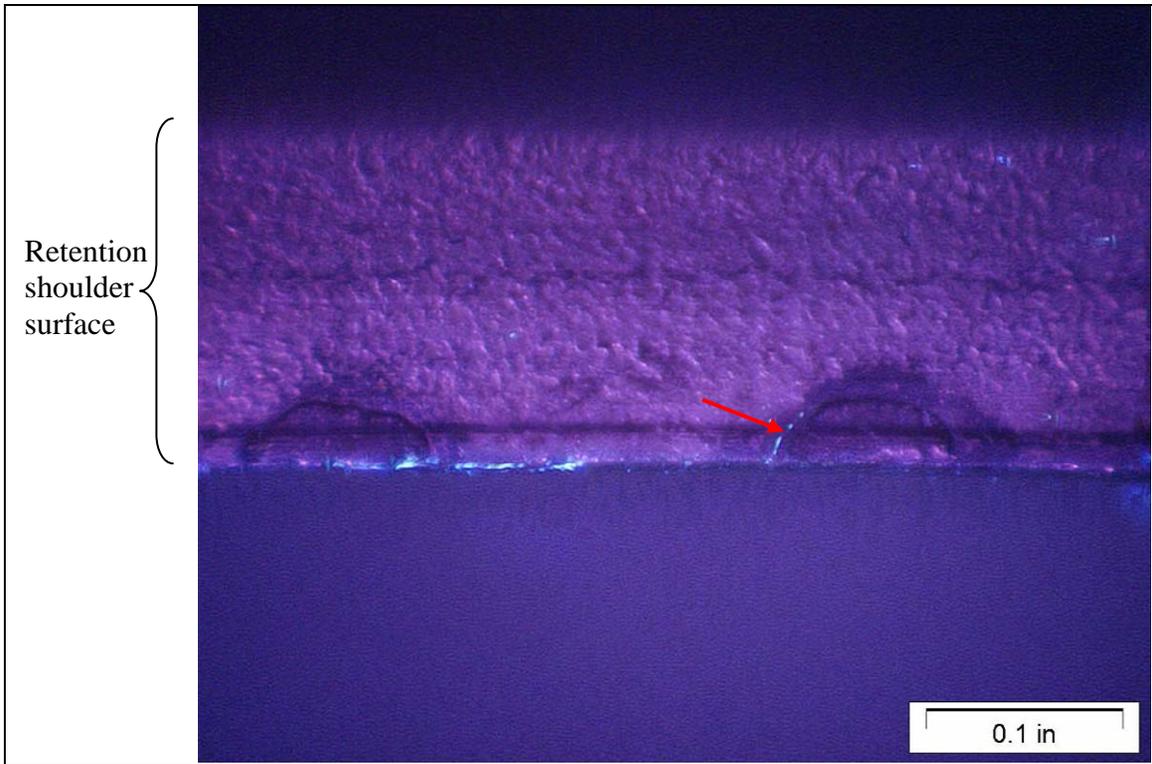
Figure 4. Black light indication of the crack at the thumbnail fretted area at hole 30.

The crack at hole 30 was similar to some of the cracks observed on the other rotating rings. This crack formed at the edge of a raised fretted thumbnail induced by damage incident to the 16.19-in-diameter surface from an unknown source. This crack can be observed in figures 4 and 15. The crack was very small, measuring approximately 0.035 in long \times 0.005 in deep. Due to its small size and apparent similarity with the cracks on the other rotating rings previously examined, no attempt was made to open this crack for fractographic examination. It was assumed that this crack initiated and propagated by fatigue as a result of localized high stresses due to the effect of the raised thumbnail on the load distribution between the rotating ring and the bearing. Pitting corrosion was observed at two locations in this area as well as of the 16.19-in-diameter surface. The pitting corrosion can be observed in figure 16 along with the raised fretted thumbnails. There were no cracks associated with the pitting sites. It is not believed that they are associated with the damage incident to the 16.19-in-diameter surface.

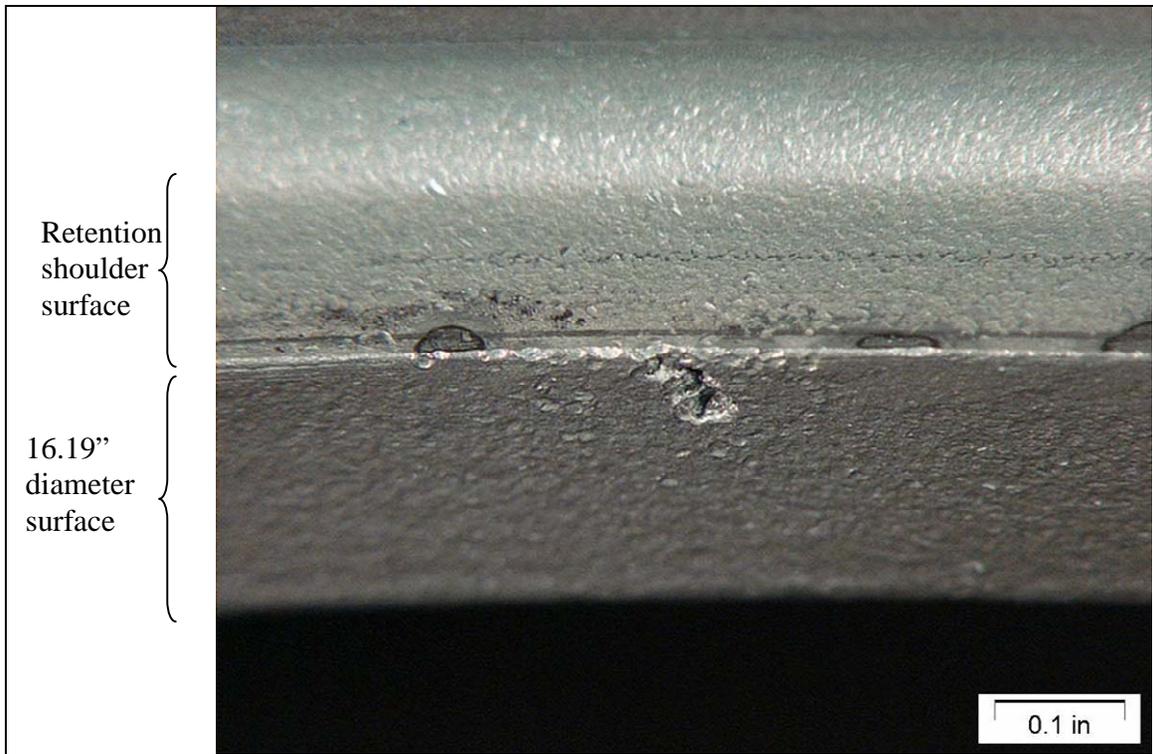
Figure 5. White light macrograph of the corrosive attack near hole 30.

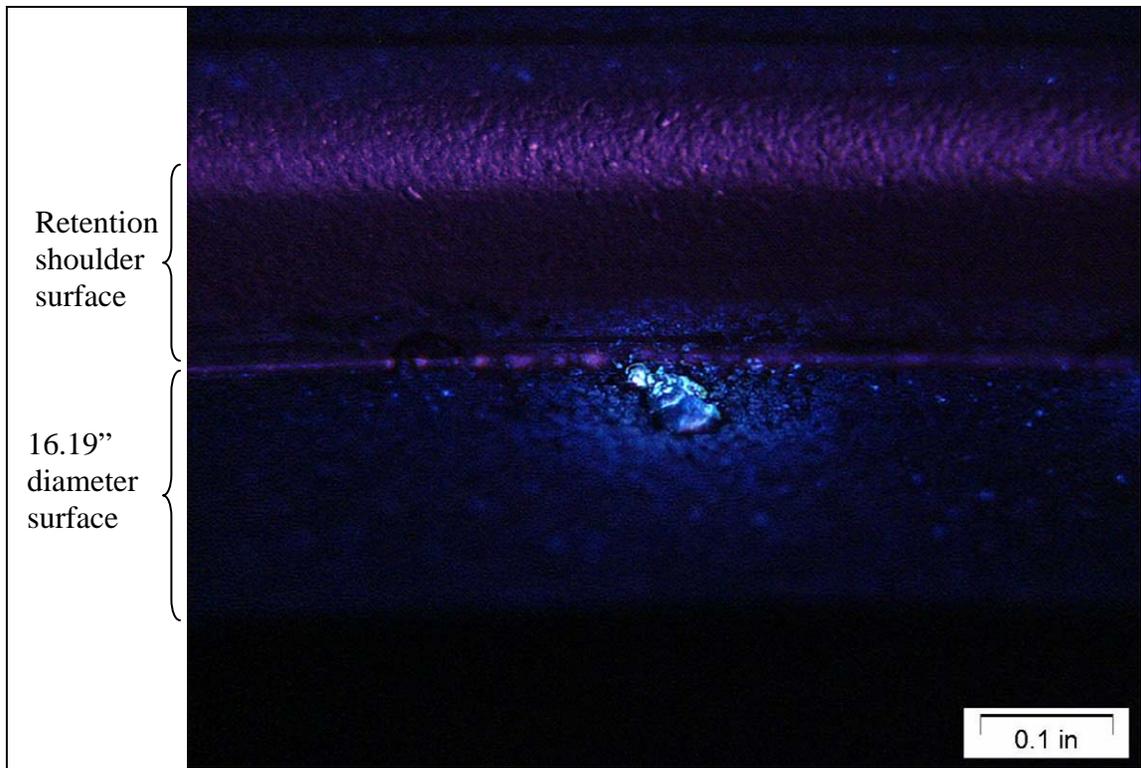
Figure 6. Black light macrograph of the corrosive attack near hole 30.

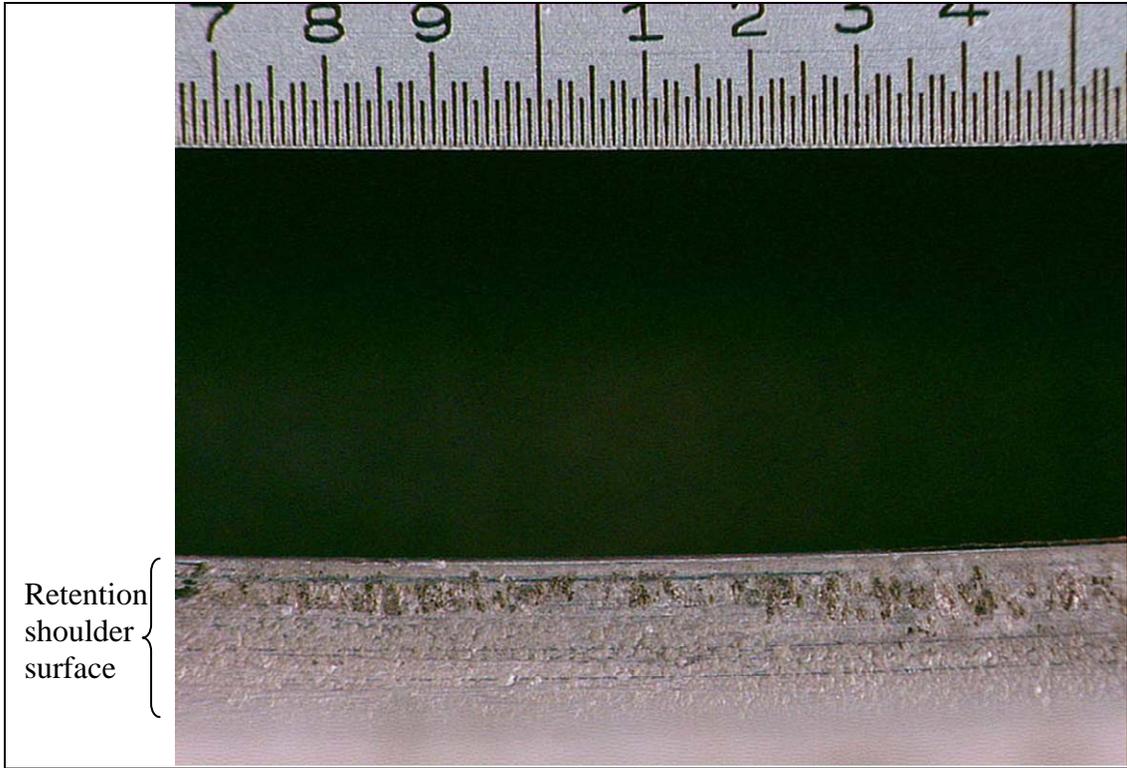
Figure 7. Typical fretted area on the bearing retention shoulder (hole 9).

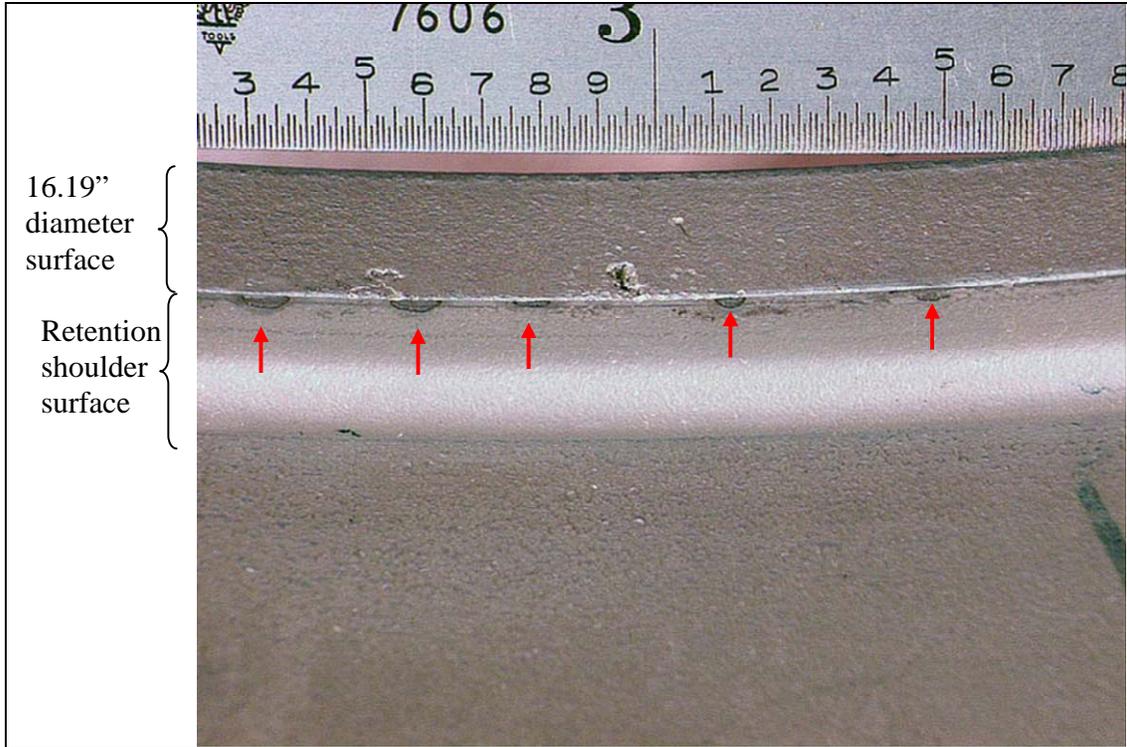
Differences in the severity of the wear step were most likely due to the loads applied to the components, slight differences in dimension, and time in service coupled with the service conditions. Although the wear step on BCW-1379 appeared less severe than the wear step observed on the other two rings, examples of similar damage mechanisms were apparent. Significantly fretted areas were observed at holes 3–4, 6, 9, 15–17, 26, 27, 32, and 35. An example of a significantly fretted area is depicted in figure 7. Raised areas where damage on the 16.19 in diameter caused material to be pushed up on the bearing retention shoulder could be observed at holes 9, 11, 13, 16, 20, 23, 30, and 34. These raised areas only had considerable fretting at holes 20, 30, and 34; however, the raised areas at hole 30 can be observed in figures 8 and 16. The damage to the 16.19-in-diameter surface is highlighted for clarity in figure 9. Compare figure 9 with figure 8. The damage at the left in both photos is the most obvious.

Figure 8. Typical raised fretted areas associated with 16.19-in surface damage (hole 30).

Elimination of the procedure and/or tool causing the damage on the 16.19-in-diameter surface seems prudent. This is most likely occurring at overhaul and is the most prominent cause of localized high stresses on the bearing retention shoulder of the rotating rings.

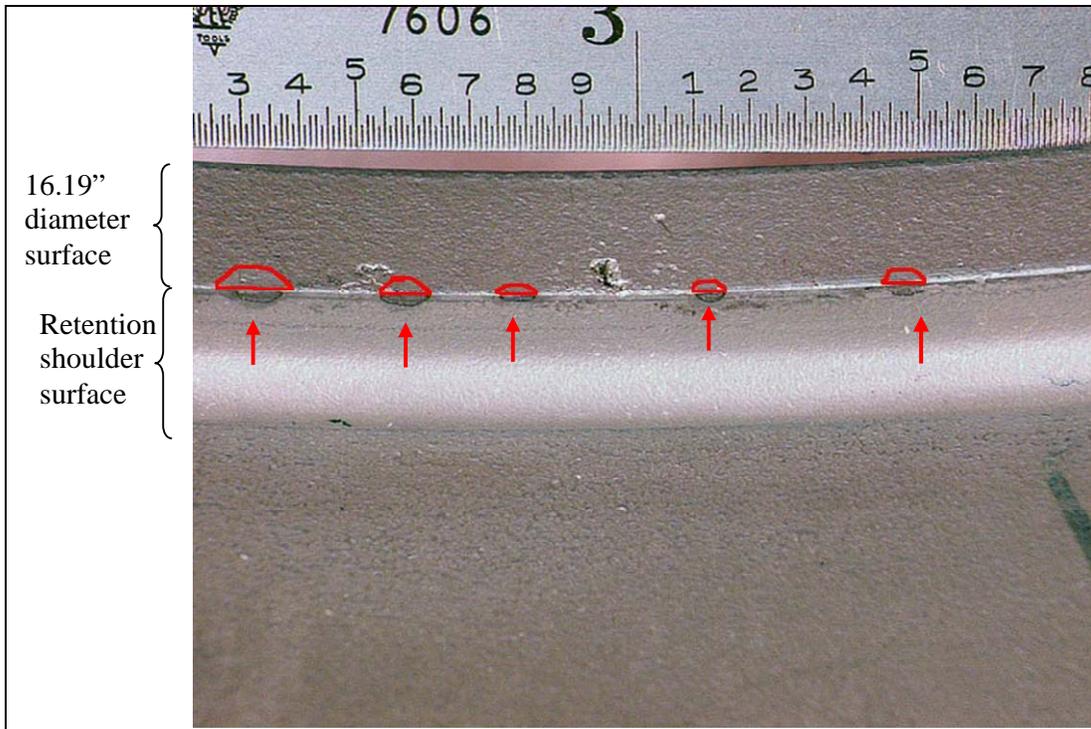
Figure 9. The damage causing the raised fretted areas associated with 16.19-in surface.

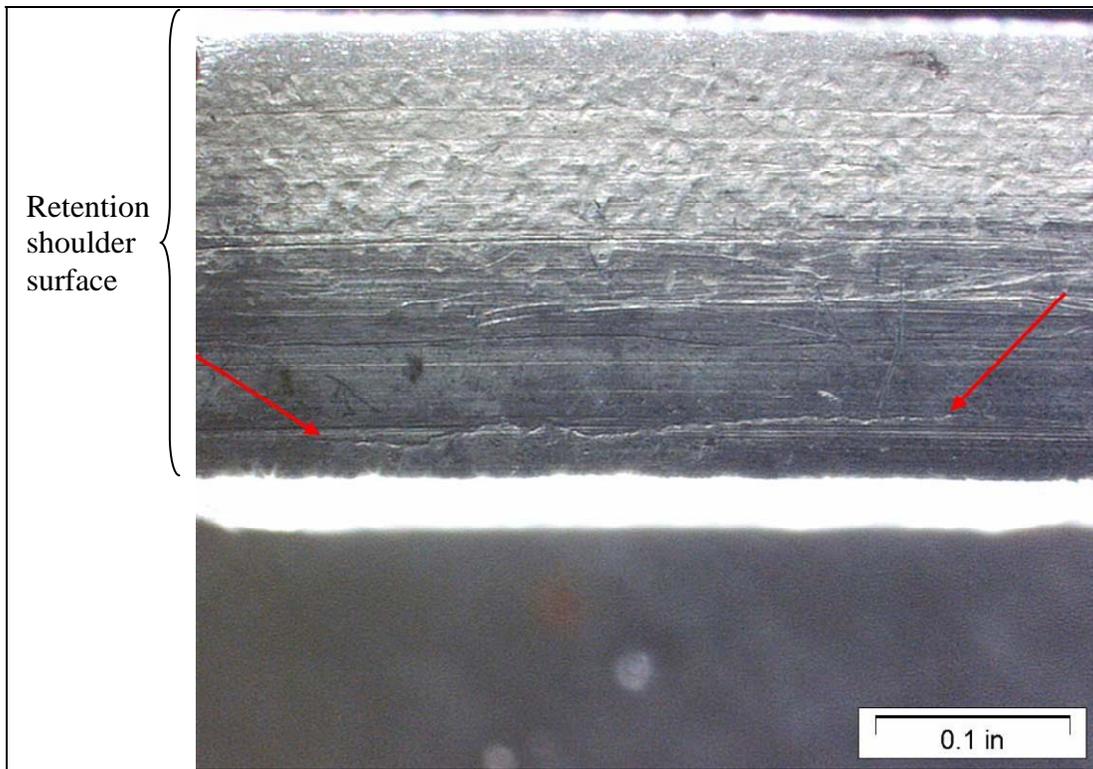
The crack at hole 5 was atypical of the previous cracking observed on other rotating rings. There was no apparent fretting wear in the area. There did exist, however, a circumferential score line that ran along the path where the crack initiated. This score line extended approximately 3 in along the circumference in this area and is clearly visible in figures 2, 9, and 10. A similar score line was apparent at other locations around the circumference of the bearing retention shoulder surface. It appeared to be an impression left by the edge of the outer race of the mating bearing and the contact loading between the components. Although the bearing that mated with this rotating ring was not available for inspection, the team examined a similar bearing from another rotating ring. This “representative” bearing exhibited raised machining marks on the edges of the inner and outer races of the bearing. The crack at hole 5 was circumferential, approximately 0.35 in long, and only 0.015 in from the 16.19-in-diameter surface. It initiated and propagated circumferentially (see figures 10 and 11). The circumferential cracks observed on other rotating rings initiated near the outer edge of the wear step (approximately 0.90 in away from the 16.19-in-diameter surface) and quickly turned radially in favor of the service stresses on the component. To determine if the crack was the edge of a machining burr rolled over by subsequent shot peening, a section was made through one end of the crack and examined metallographically. Figure 12 shows the resulting cross section clearly indicating that the crack

Figure 10. Photograph 1 of the circumferential crack at hole 5.

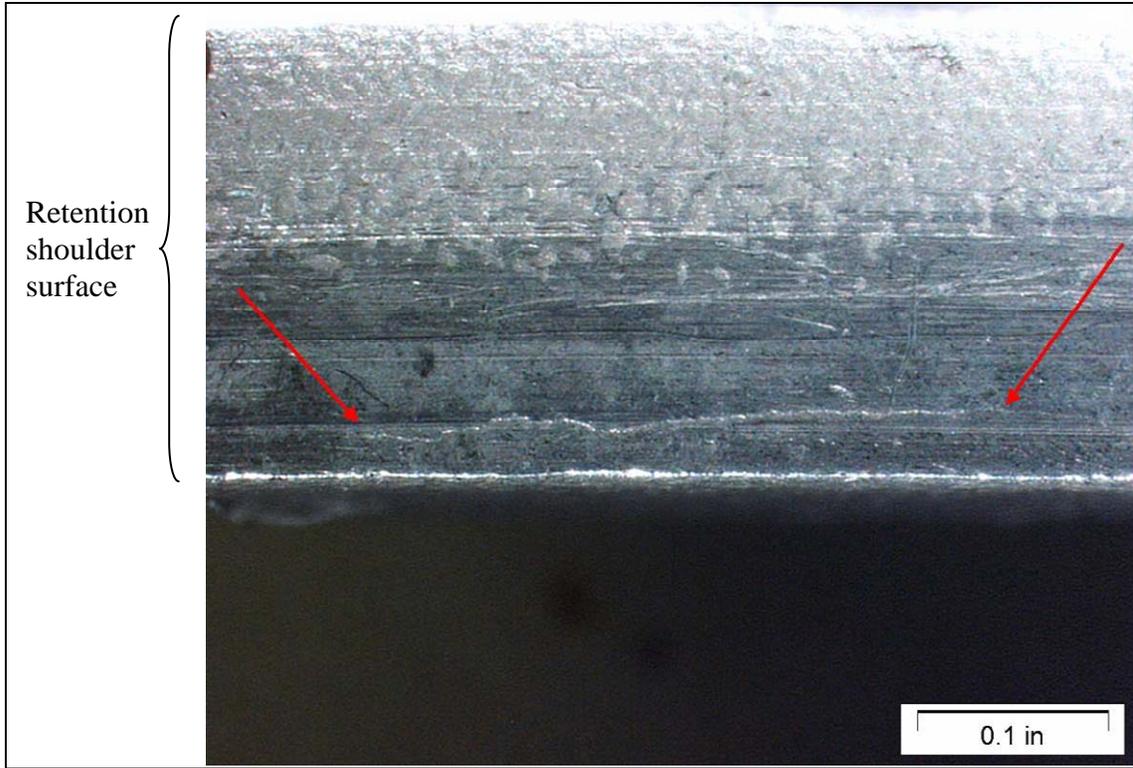
Figure 11. Photograph 2 of the circumferential crack at hole 5.

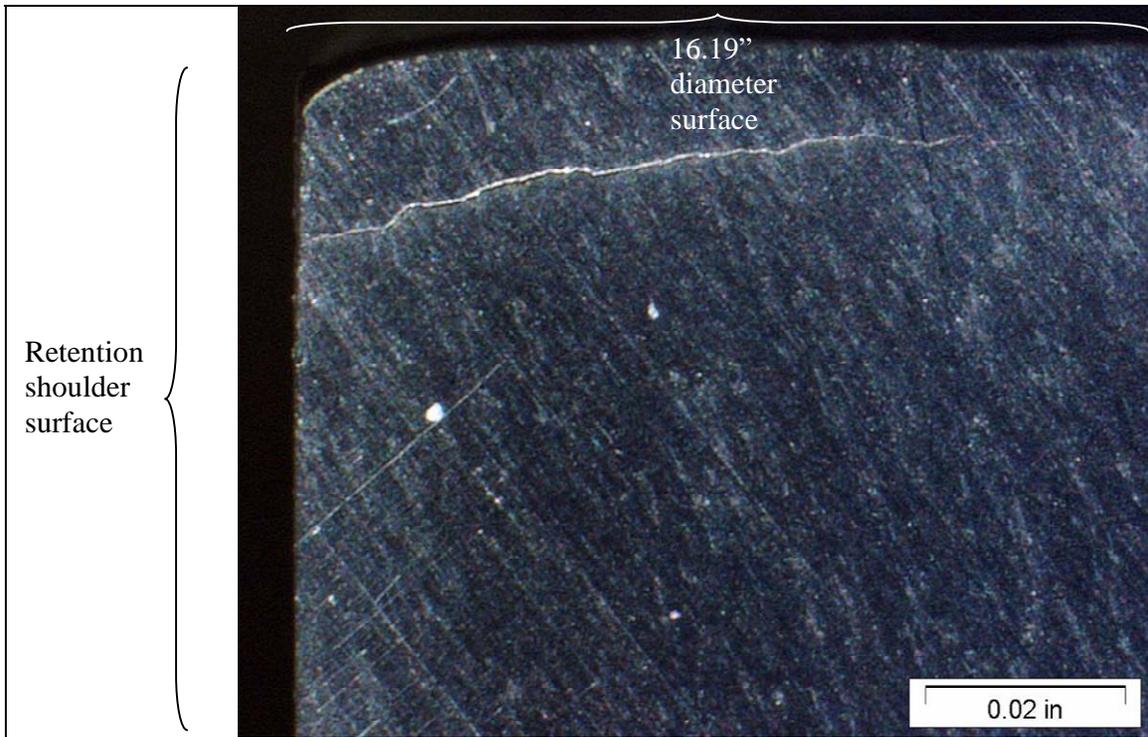
Figure 12. Cross section of the crack at hole 5.

had considerable depth and was not simply a rolled-over burr. It can also be seen in this figure that the crack roughly paralleled the 16.19-in-diameter surface and would have likely propagated considerably farther in both the axial and circumferential directions before contacting the exterior surface of the component. The crack was then opened for fractographic examination.

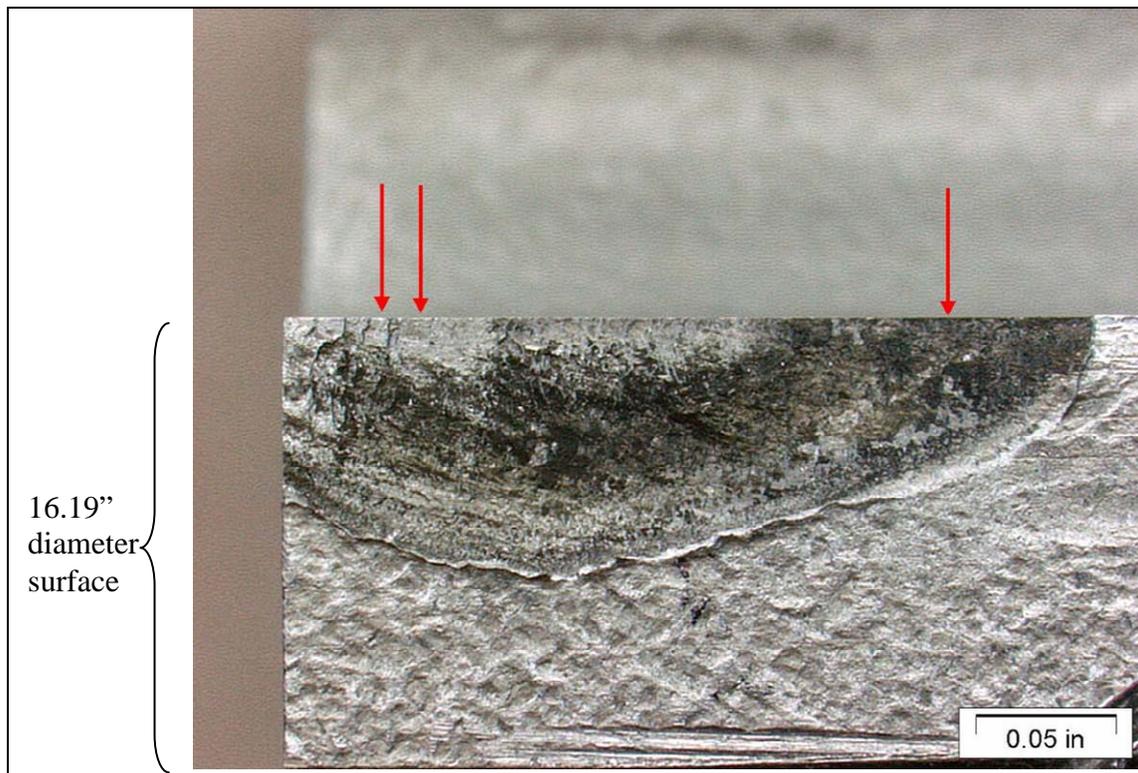
Examination of the crack's fracture surface revealed at least three origins, all initiated by fatigue on the bearing retention shoulder surface. The beach marks and radial lines suggested it was unlikely that more origins existed within the material consumed during metallographic preparation, prior to the crack being opened (observable in figures 13 and 14). The crack propagated by fatigue from these three origins to a total depth of 0.090 in and a total estimated length of 0.350 in. Figures 13 and 14 depict the fracture surface with red arrows and lines indicating the crack origins and propagation fronts, respectively. A black product was visible on approximately half of the fracture surface; this product was analyzed with Energy Dispersive Spectroscopy (EDS) (and discussed within the SEM section of this report). The depth of the wear step at hole 5 was approximately 0.001 in. No mechanical damage was noted on the 16.19-in-diameter surface in the area of the crack and no other anomalies were observed in this area.

Figure 13. Fractograph of the opened crack at hole 5 (arrows indicate origins).

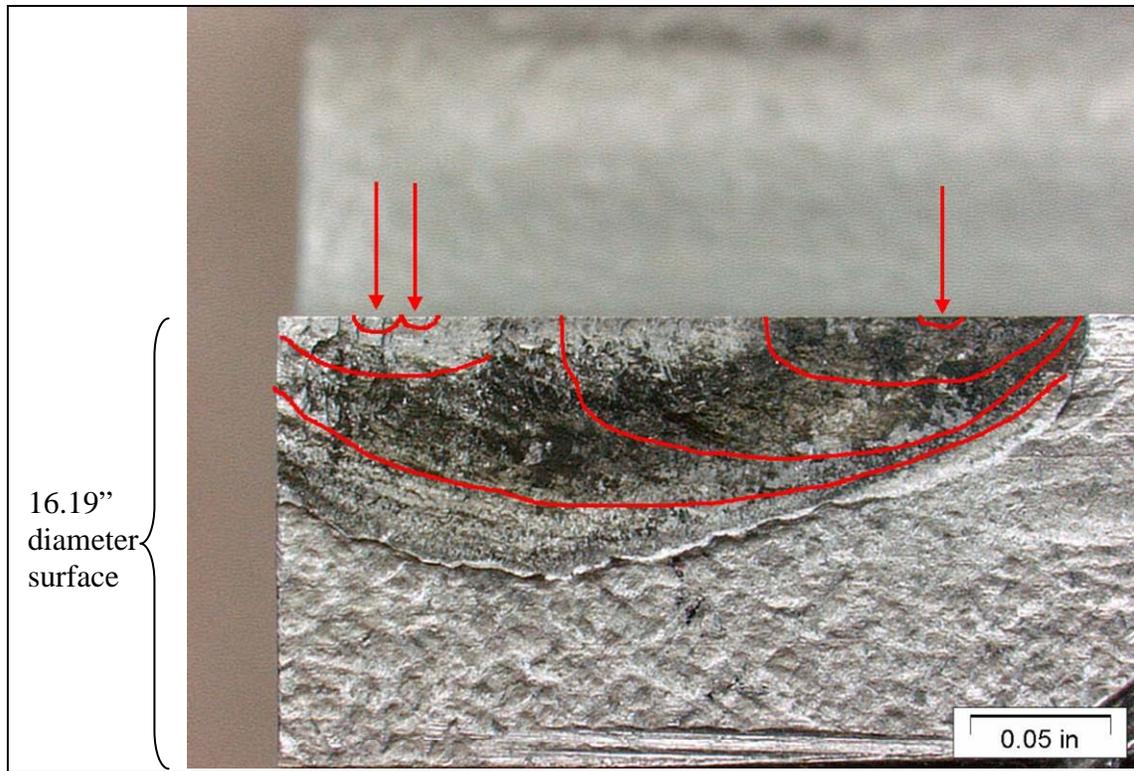
Figure 14. Fractograph of the opened crack at hole 5 with propagation lines.

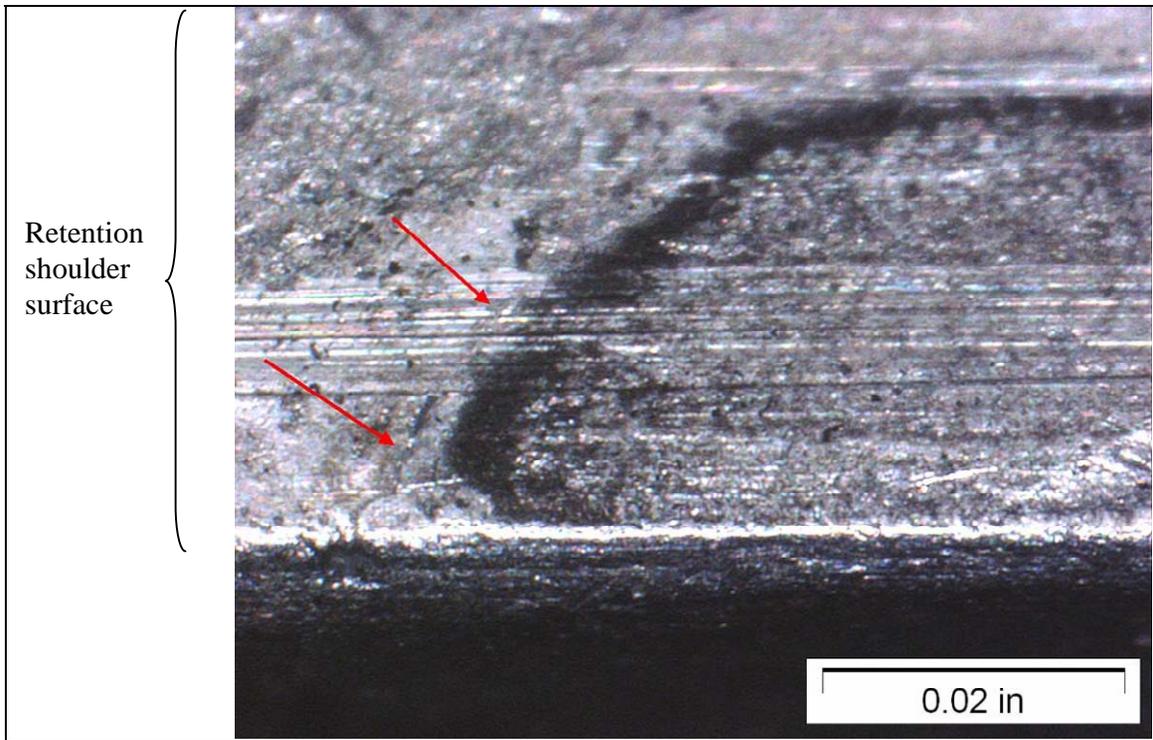
Figure 15. Crack at a raised fretting site located at hole 30.

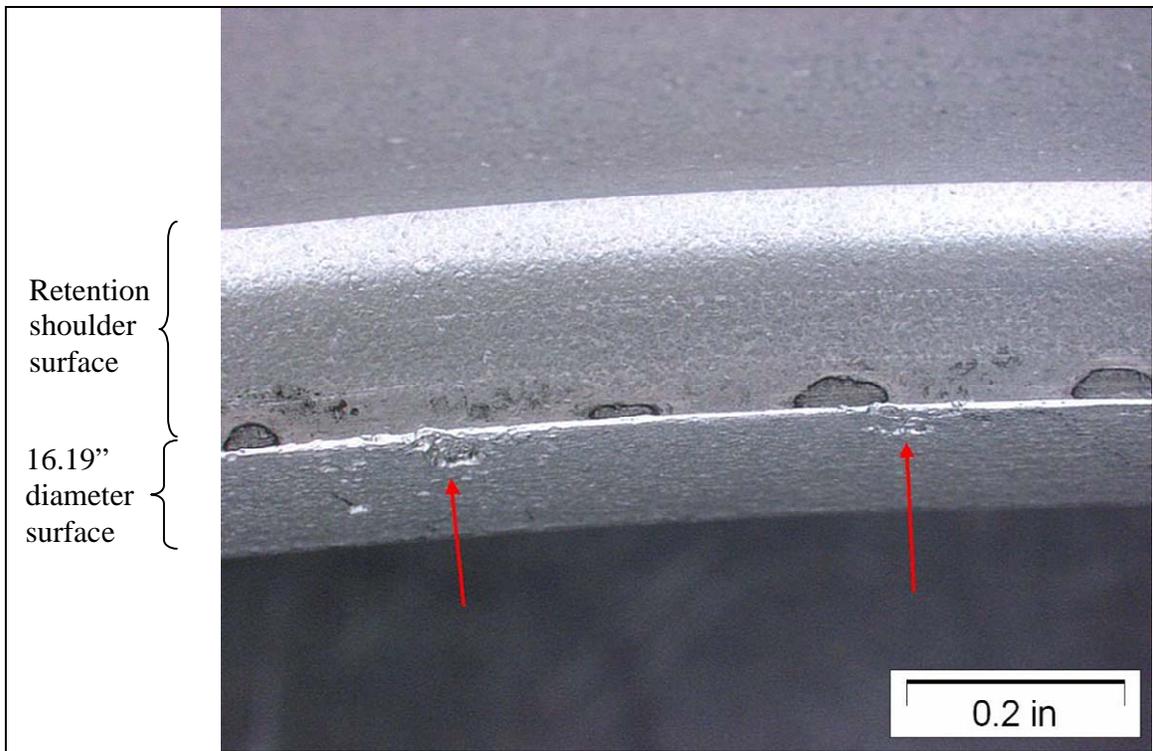
Figure 16. Corrosion pits and raised fretted areas at hole 30.

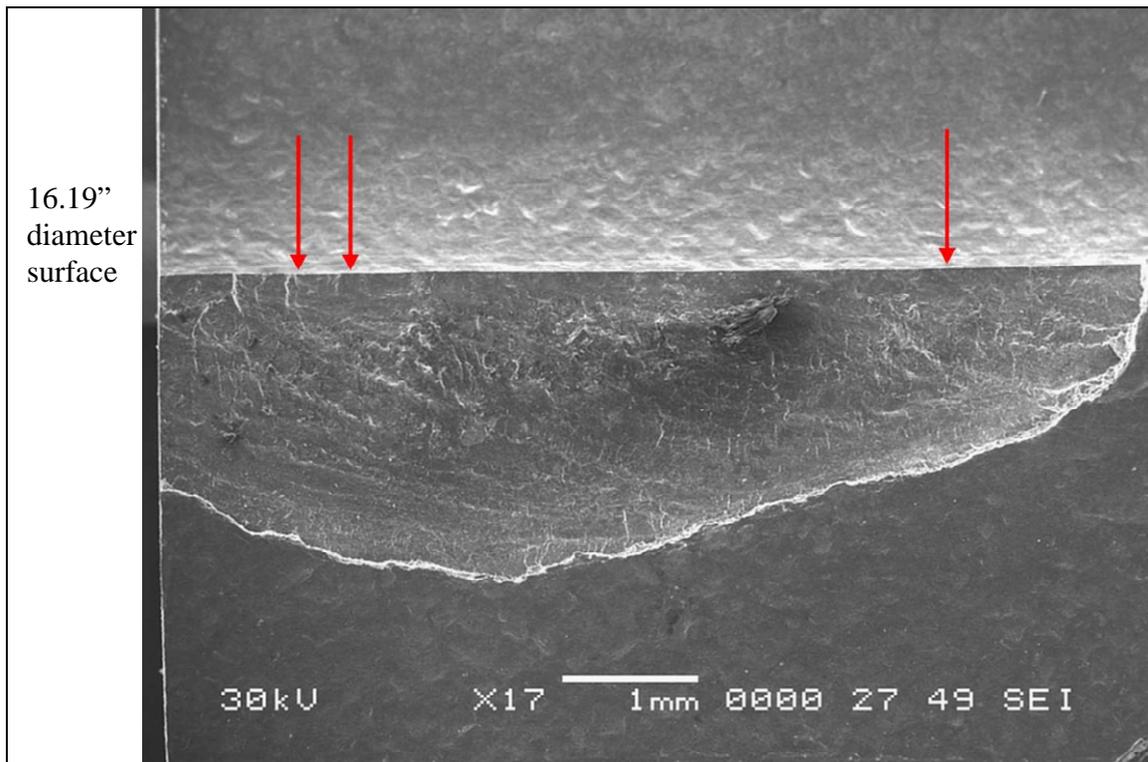
SEM utilizing a JEOL-JSM 6460-LV was performed to investigate the fracture surfaces in greater detail. The crack at hole 5 is depicted in the electron fractograph in figure 17. At closer inspection, evidence of cyclic fatigue crack propagation was present (figure 18). The fracture morphology was transgranular throughout the cracked region. EDS was utilized to analyze a dark product on the fracture surface. The product appeared to have high peaks for oxygen and aluminum, indicative of oxidized aluminum and that this crack either took a long time to form or formed quite a while ago. No more specific information about the age of the crack could be determined. This spectrum can be observed in figure 19. Aside from the wear step and the score line previously described, there was no significant mechanical damage or corrosion present at the origins.

Figure 17. SEM fractograph of the crack at hole 5.

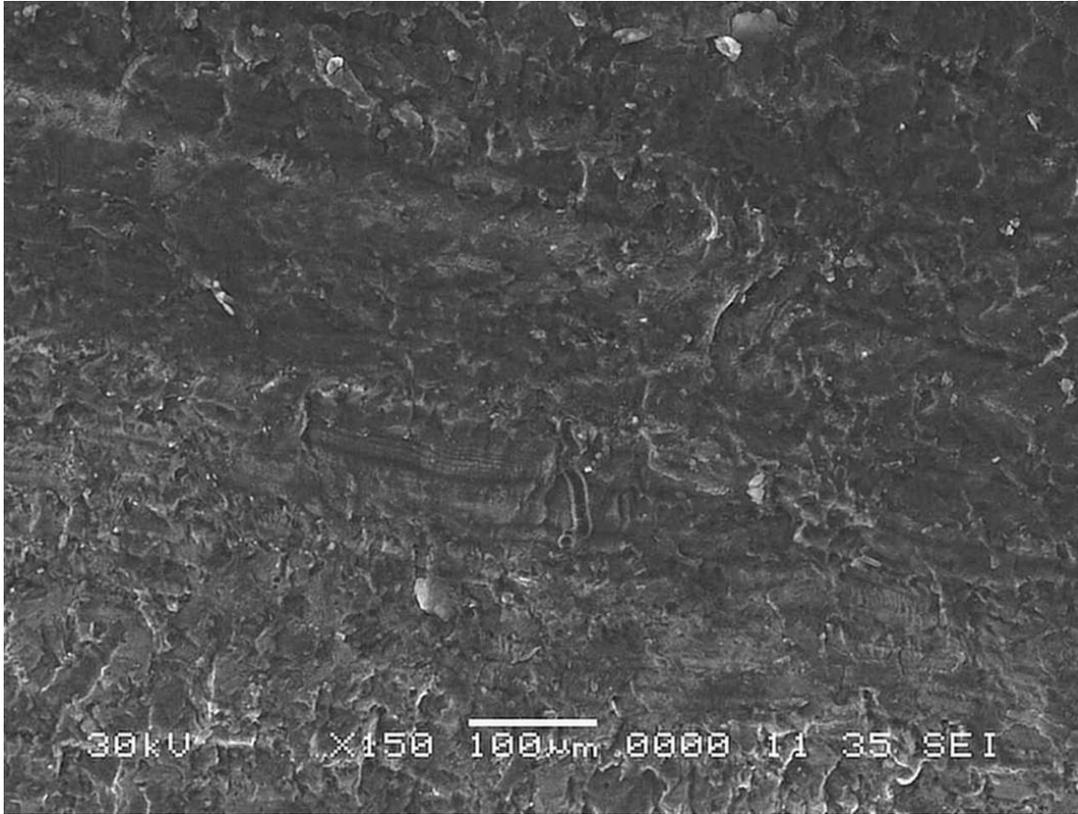
Figure 18. SEM micrograph depicting cyclic crack propagation at hole 5.

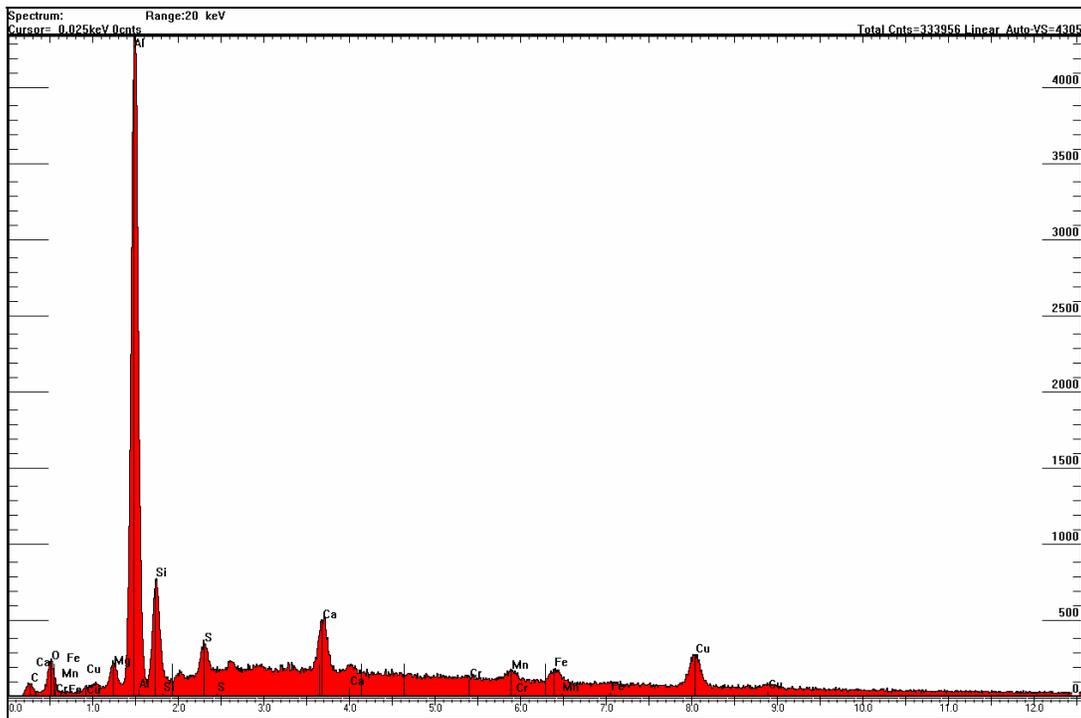
Figure 19. EDS spectrum from the black product on the fracture surface at hole 5.

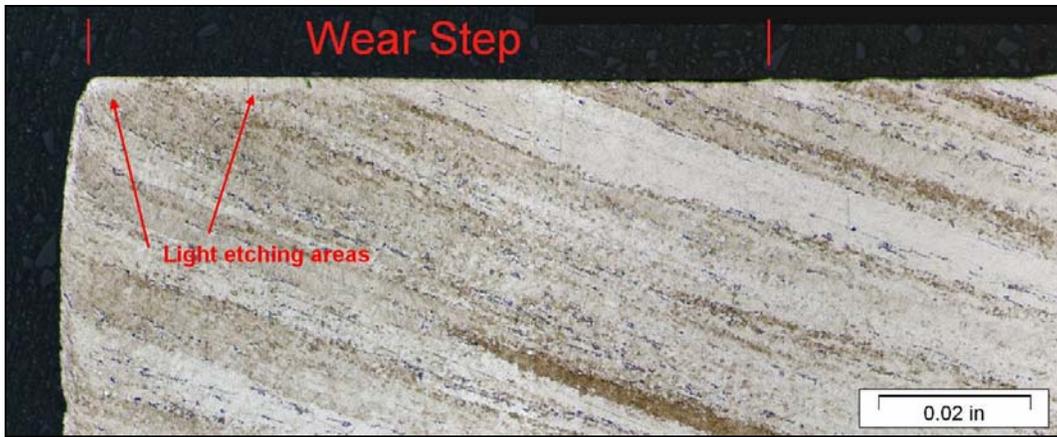
Figure 20. Microstructure near the wear step.

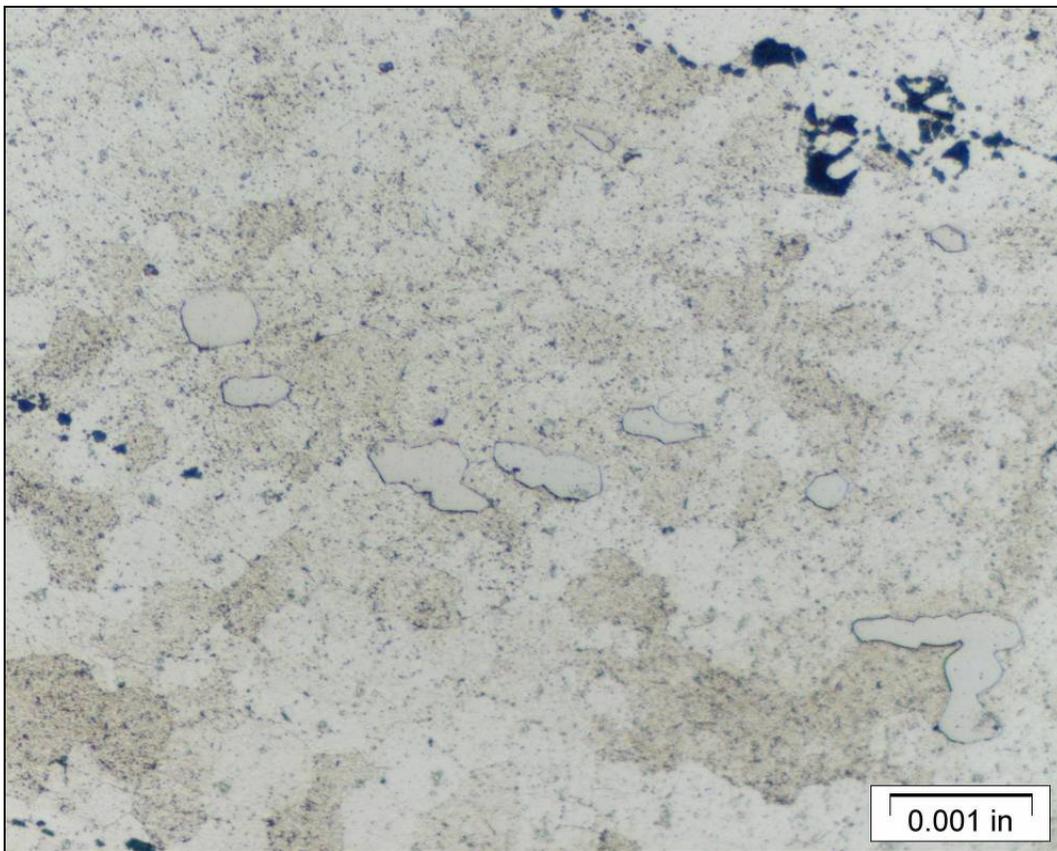
Figure 21. Typical microstructure of aluminum 2014-T6 base material.

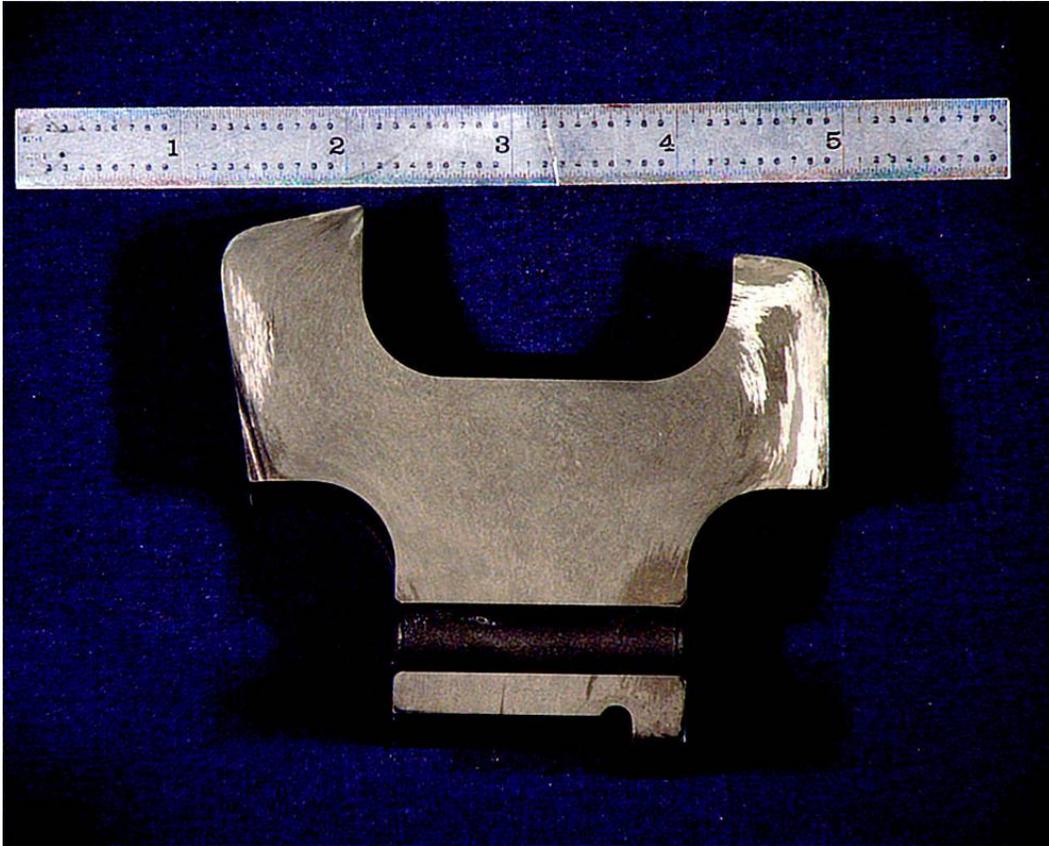
A radial cross section was prepared through the bearing retention shoulder. The section was ground and polished through 0.025- μm noncolloidal silica. Subsequently, the specimen was etched with Keller's reagent. The microstructure of the rotating ring material was found to be consistent with 2014-T6 aluminum. The depth of the wear step was believed to be at its maximum in this cross section and measured approximately 0.001 in. The onset of strain hardening of the material below the wear can be observed as a light etching effect. The microstructure beneath the wear step can be observed in figure 20. The typical microstructure of the base material is depicted in figure 21. No other abnormalities were observed. A radial cross section was also evaluated for the grain flow induced by forging. The section was polished and macro-etched with NaOH. Forging flow lines were observed generally following the contours of the component, confirming that the component was forged as required by the engineering drawing. The grain flow pattern is shown in figure 22.

Figure 22. Macro-etch of a radial section depicting forging flow lines.
