Flightfax

ARMY AVIATION
RISK-MANAGEMENT
INFORMATION

MAY 1998 ♦ VOL 26 ♦ NO 8

Never stop flying the aircraft . . .

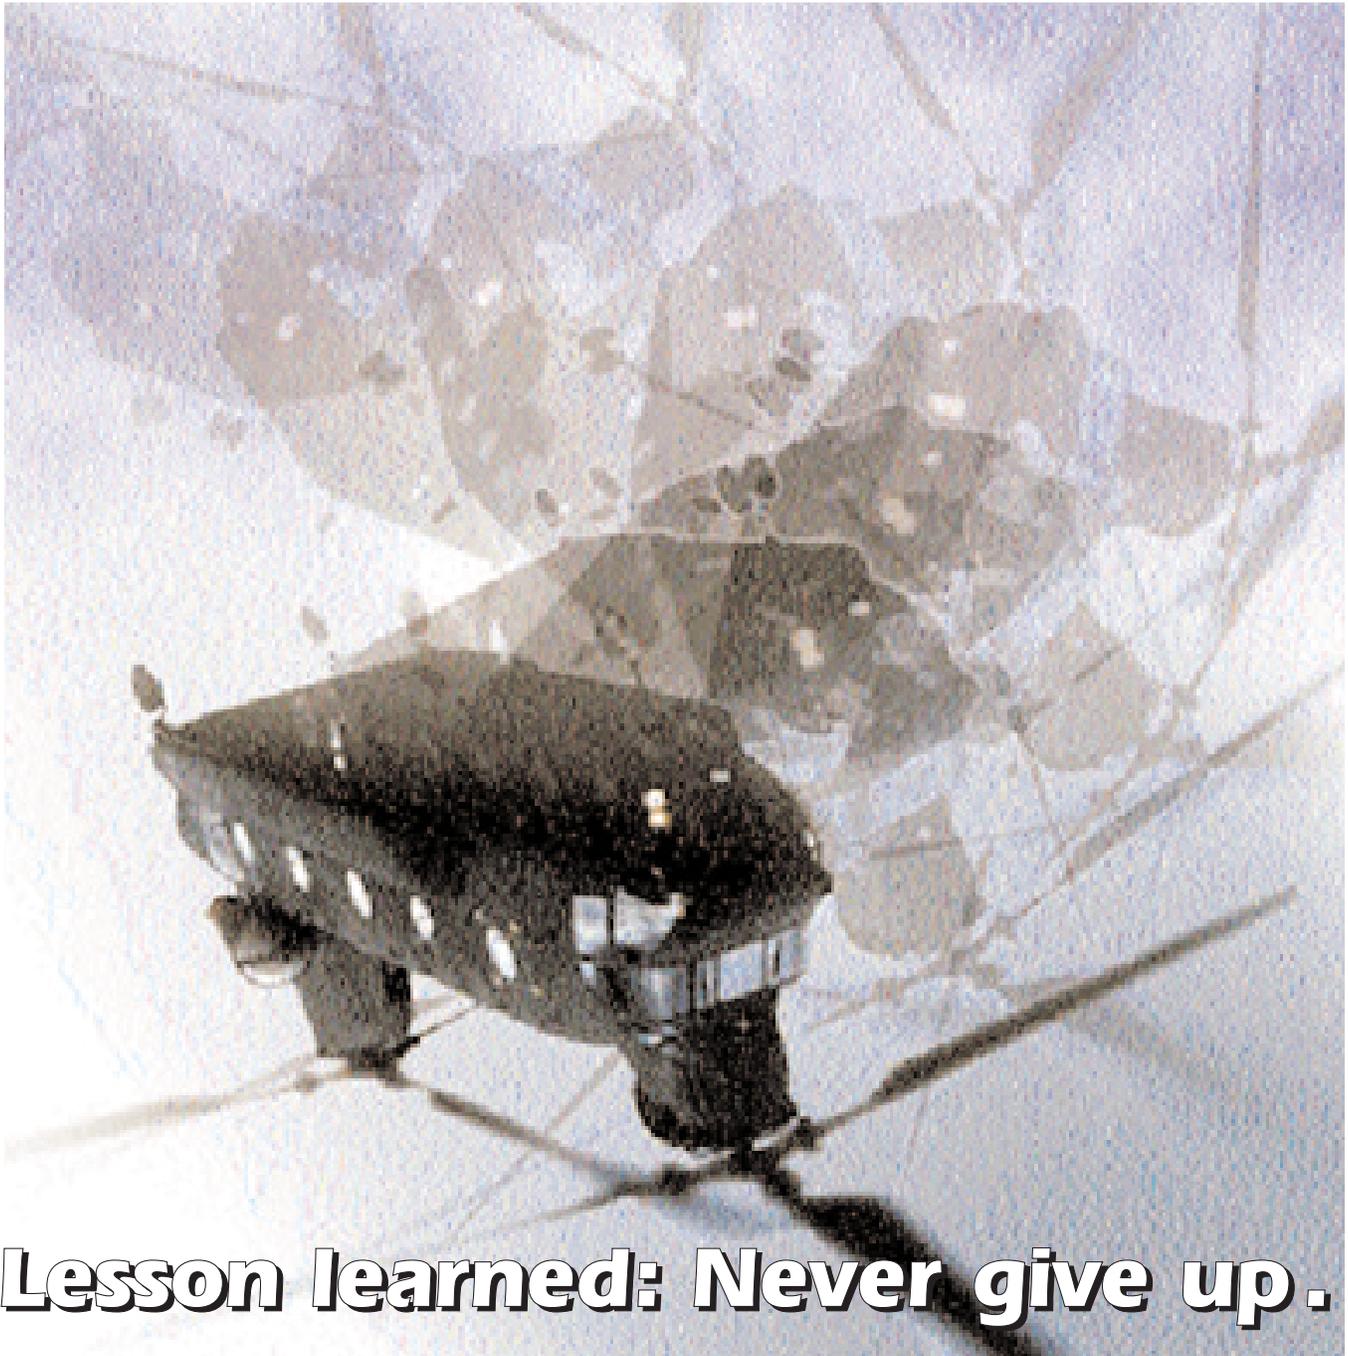
After 360-degree roll in flight, the crew managed to land the Chinook with surprisingly little damage. During shutdown, however, damaged droop stops allowed the aft rotor blades to pound into the fuselage.
