ARMY AIRCRAFT SAFETY PERFORMANCE REVIEW

December 1992

Army Aircraft Safety Performance

FY
87

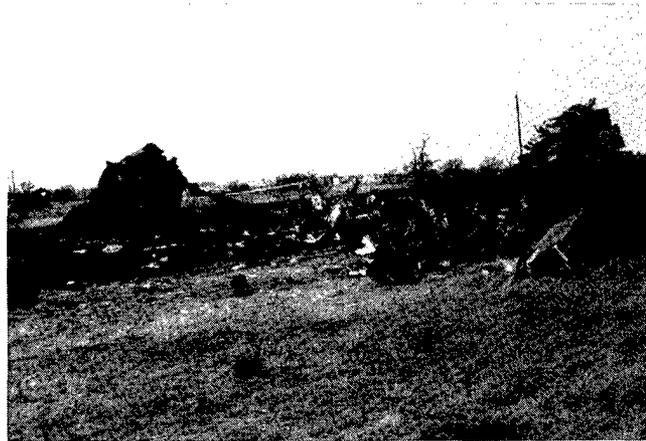
Materiel failure

About 5 minutes into the second leg of a service mission, while in cruise flight at 500 feet msl, the aircraft caught fire in the left side area of the aft pylon. The fire spread rapidly, engulfing the entire pylon. Drive from the No. 1 engine was lost, and the crew initiated an emergency descent. The aircraft became uncontrollable and was observed to roll left, then right, followed by a nose-down roll to the left just before impact. The aircraft came to rest on a 21-degree downslope, oriented in a direction opposite the direction of flight. The aircraft was destroyed by fire.

Recommended actions: Convene a task team of appropriate agencies to study possible failure modes and scenarios and develop corrective actions. Improve emergency descent procedures in the operators manual.
