## Communication and Noise Hazard Survey of CH-47D Crewmembers

November 1995

U.S. Army Aeromedical Research Laboratory  
Fort Rucker, Alabama 36362-0577

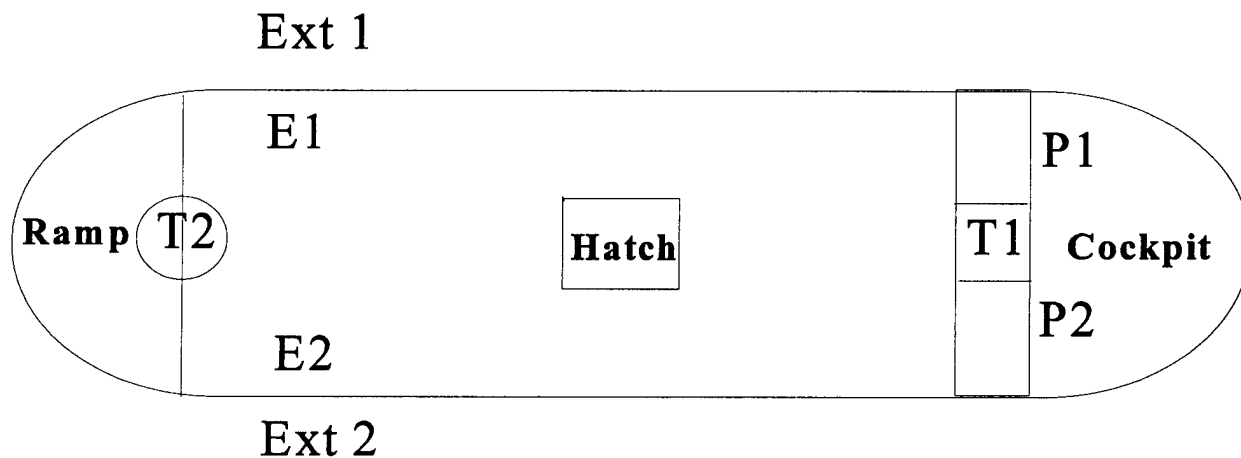
The CH-47D configuration is unique with two large fore and aft transmissions and two corresponding sets of rotor blades as shown in Figure 1. The auxiliary power unit (APU) is another noise source in proximity to the aft transmission. As a result crewmembers, whether fore (aviators) or aft (crewchiefs), are exposed to significant noise levels during normal operations.

Figure 1. Top-view schematic of the CH-47D aircraft showing sound measurement and noise source locations: Pilot stations in the cockpit (P1, P2), crewchief stations (Hatch, Ramp), transmission and rotor systems (T1, T2), engine systems (E1, E2), and sound measurement stations external to the aircraft (Ext 1, Ext 2).

Respondents (N = 17; 16 male, 1 female) were members of a U.S. Army Reserve CH-47D unit. A survey was distributed to the subjects during their annual summer camp. In-flight noise levels were measured on two consecutive days in two CH-47D aircraft using a Rion™ sound level meter, model NL11, at locations noted in Figure 1. These are positions where CH-47D crewmembers work during normal operations. Air speeds during measurements ranged from 80 to 160 knots.

\* See Figure 1 for locations.

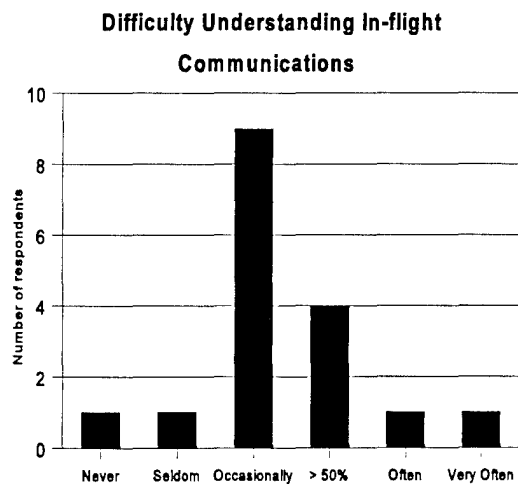
Figure 2. Frequency of in-flight communication problems.

When respondents were asked how frequently they experienced in-flight communication difficulties, 8 (47%) answered "occasionally" as shown in Figure 2. Six out of 17 (35%) reported communication problems were occurring more than half of the time. Aviators are required to monitor several communications channels simultaneously to include radio, intercom, warning, and navigational signals. Figure 3 presents the mean values of crewmember responses when asked to rank the most demanding condition during flight operations with respect to communications. The higher the value, the greater the criticality of the condition. "Multiple trans." refers to a condition where more than one radio channel is active with incoming traffic. "ICS" refers to the intercom system (i.e., within the aircraft). "ILS" refers to the instrument landing system, which is used when visibility is low and aviators must rely on instrumentation to determine altitude, speed, heading etc. "Fire guard" duty refers to the position of the crewchief outside the aircraft during engine start and refueling with engines running. In this situation, the crewchief communicates with the pilot via the ICS. "Other" refers to hoist operations, sling loads, and operations in confined areas. "Landing", "Take-off", and "Night" are self-explanatory.

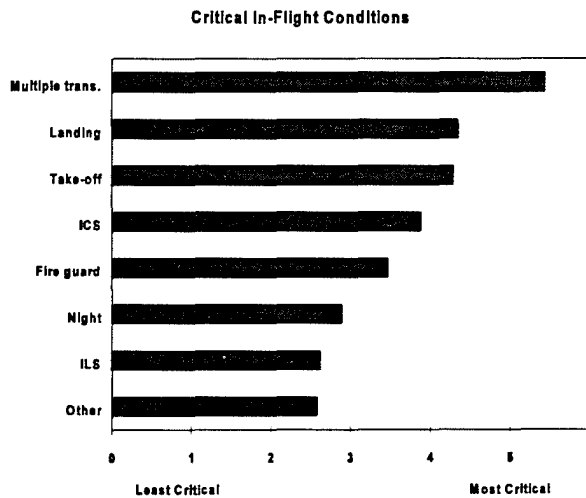
Figure 3. Criticality of communications during phases of flight.
